Service Action: Install Door Sill Trim Strips

NEW E71 (X6 xDrive35i and X6 xDrive50i) with M Performance Package (option ZMX)

Produced from March 2012 to May 2012

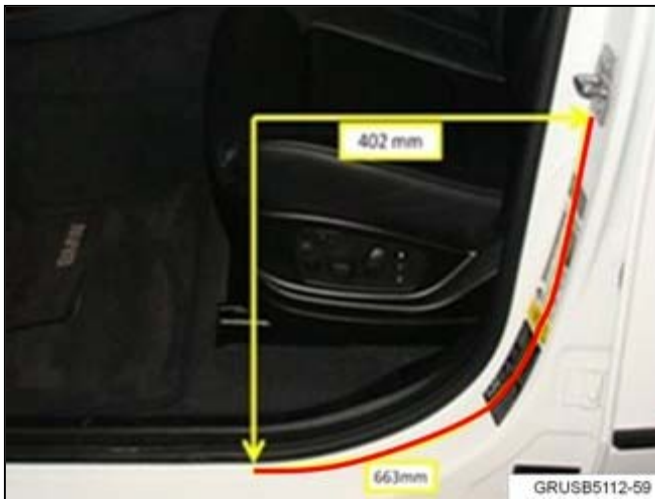
The door sill trim strips were not installed.

1. Measure the distance from the bottom of the front door striker. The distance must be 402 mm (15.8 in). Transfer the distance to the bottom door sill and mark with a wax pencil, masking tape or suitable marker. The mark represents where the rear edge of the front sill trim strip will be
