**SUBJECT****Creaking Noise from the B-pillar****MODEL**

F07 (5 Series Gran Turismo)

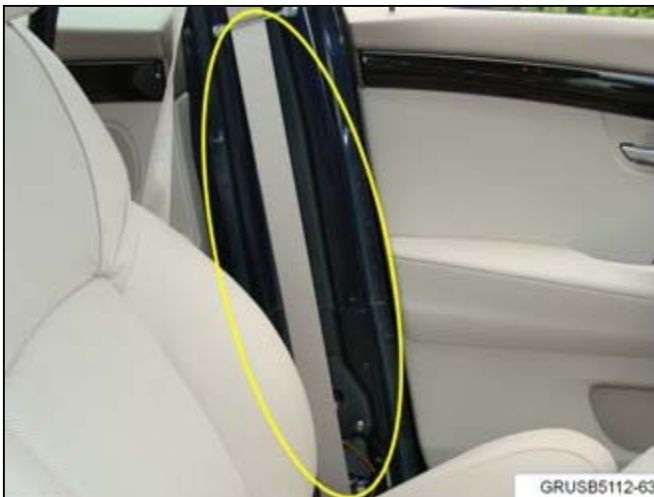
Confirm the creaking noise is coming from the B-pillar area by driving on rough roads, and then proceed to the next step.

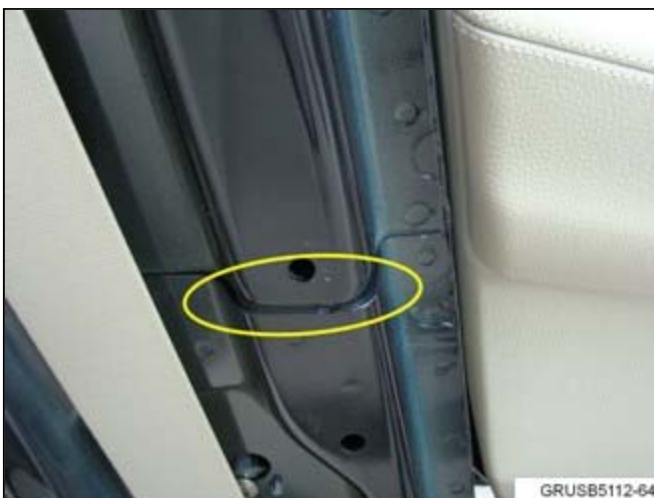
1. Using Repair Instructions 51 43 150, remove the B-pillar trim pieces from the affected side. Shown is the driver's side.

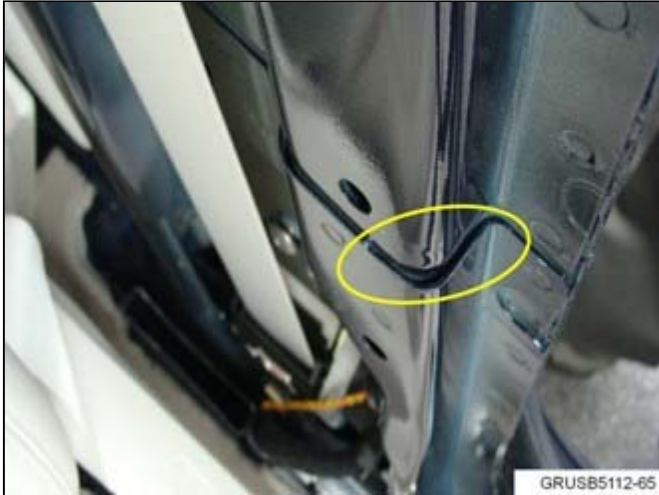
2. The area to be modified is where the two metal pieces of the B-pillar overlap.

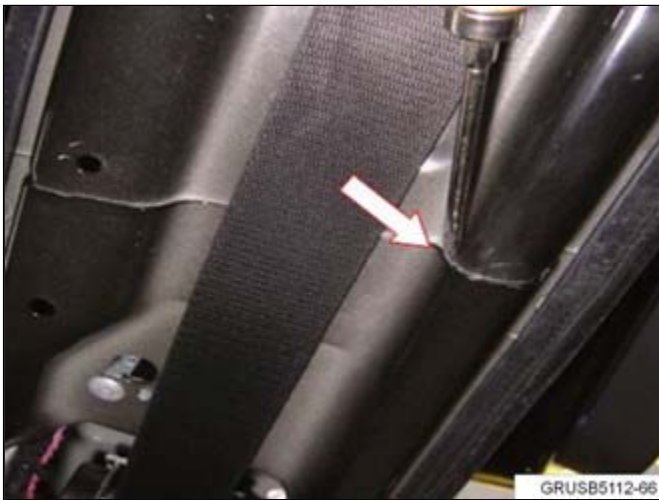
3. The view from the top shows the gap which may be the source of the creaking.
