**SUBJECT****Front Door Window/Rear Side Window Reverses when Closing****MODEL**

F12

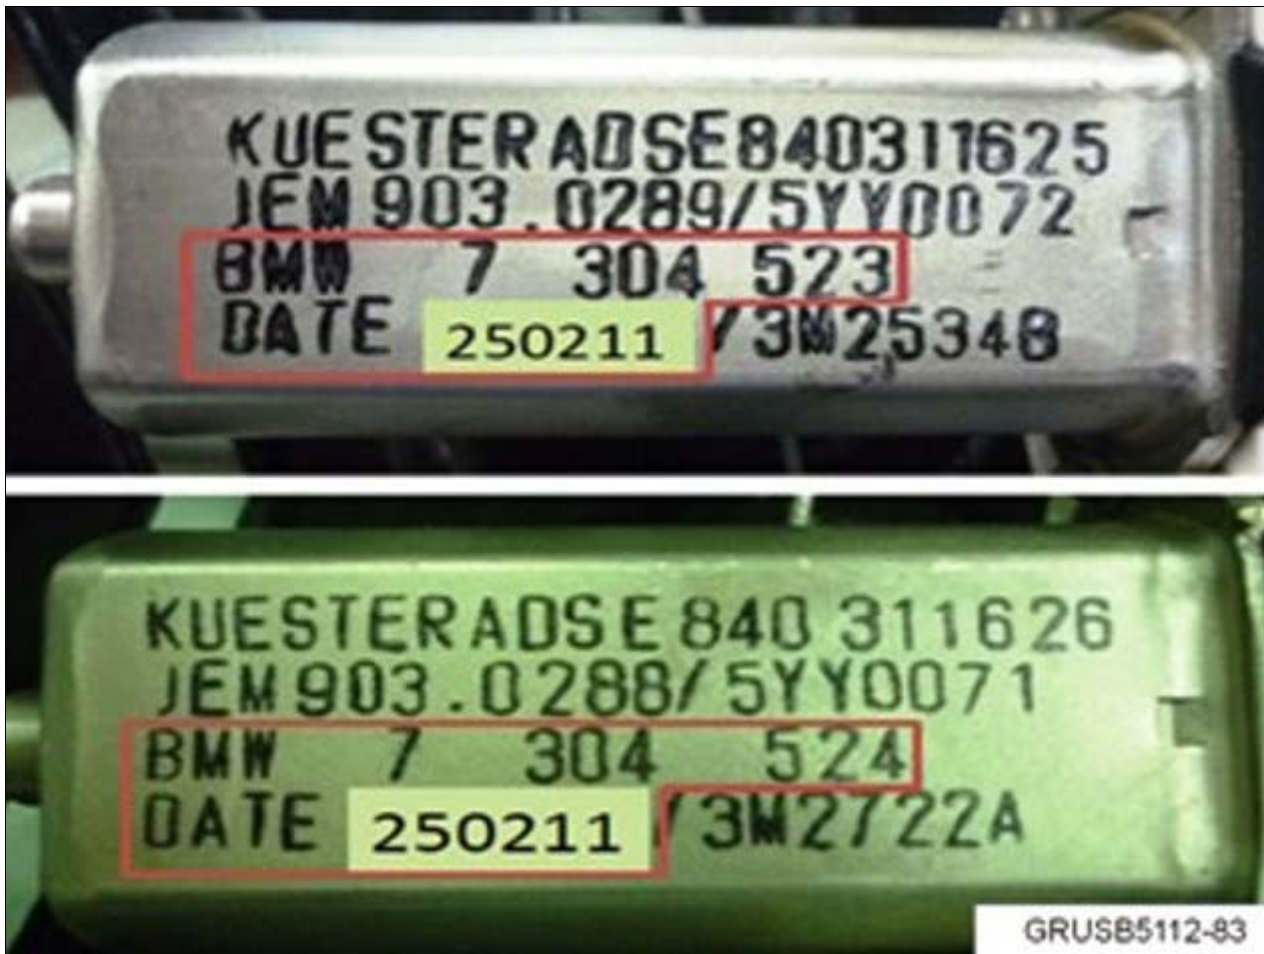
When using the automatic window closing feature, intermittently the rear window automatically reverses.

Sensitivity of the anti-trap feature

4. If the window reversing still occurs with the rear window(s), check the production date of the window drive motor. An improved version will show a date of 22 02 2011 (February 22, 2011) or later. If the date is earlier, replace the drive motor with the improved version. Note: Shown are the left and right rear window drive motor date codes (for example, 25 02 11).
