**SUBJECT****Rattling Noise from the Front Passenger Side Trim****MODEL**

F01

F02

F04

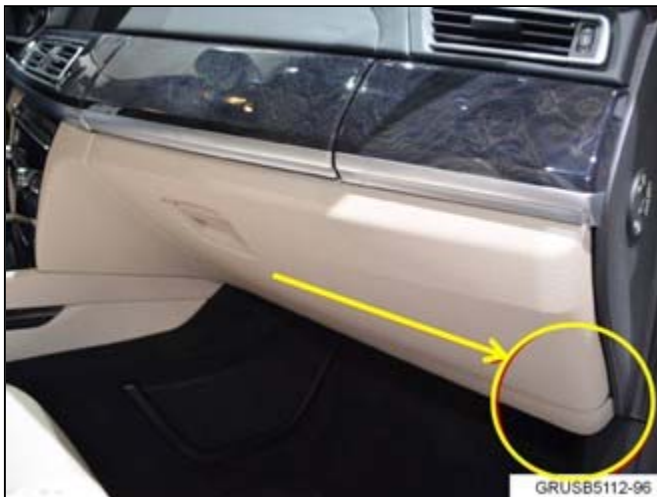
Confirm the rattling noise is coming from the footwell trim near the glove compartment bottom.

1. The area of concern is where the plastic pieces of the footwell trim make contact with the lower instrument panel trim.
