Trunk Lid Intermittently Does Not Open or Latch

E90 (3 Series)

NEW Vehicles produced from February 28, 2011 to June 30, 2011

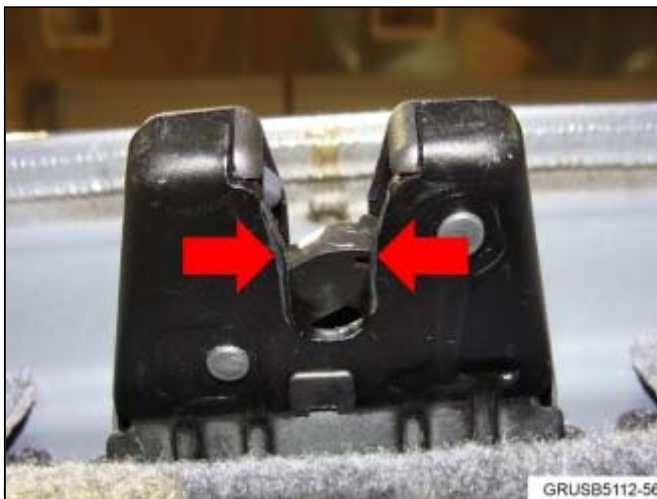
The trunk lid is out of tolerance. When opening or closing the trunk lid, the latch rubs against the striker because of insufficient clearance.

1. Inspect the trunk latch for scratch marks that indicate that the latch is engaging the striker improperly.
2. Replace the latch if scratch marks are found as per ISTA Repair Instructions "51 24 100 Removing and installing/replacing rear lid lock (upper section)."
3. Replace the striker as per ISTA Repair Instructions "51 24 130 Removing and installing/replacing striker for rear lid lock."
4. Install a spacer plate (P/N 51 24 7 348 321) between the striker

and the body before installing the new striker.
