**SUBJECT****Tail Lamp Is Loose in the Trunk Lid****MODEL**

F30

Produced from November 2011

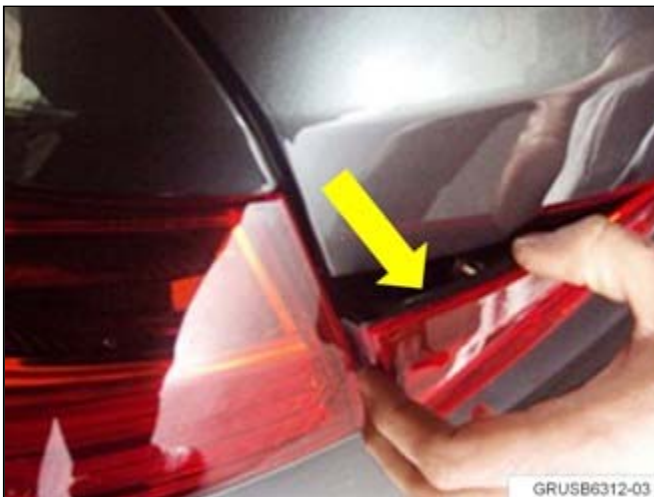
1. Check both rear trunk lid tail lamps for looseness or protrusion. If improper tail lamp fitment is noted, remove both left and right tail lamps. Refer to ISTA Repair Instruction 63 21 240 and 63 21 245.

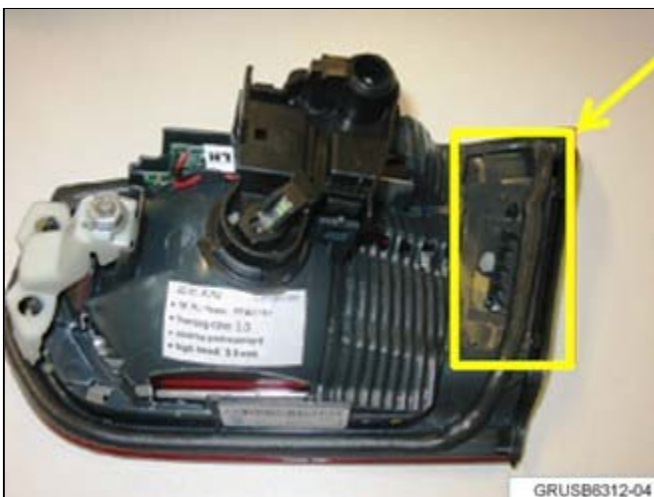
2. Place the tail light upside down on a clean work surface and locate the securing hook of the tail lamp.

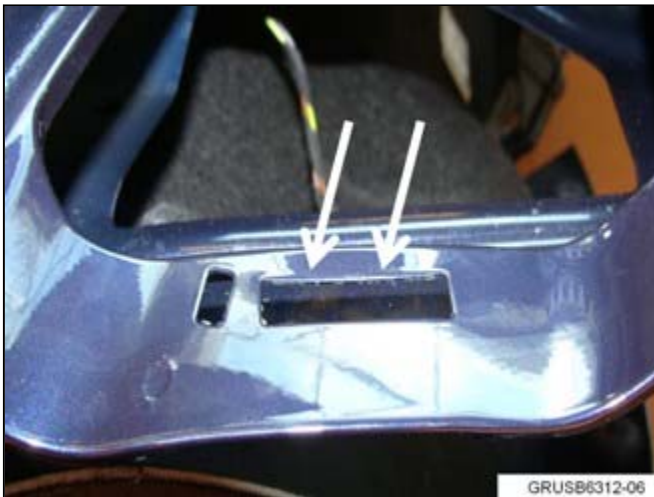
4. Before installing the taillight, inspect the trunk lid where the taillight was removed. Check the sheet metal area where the taillight hook is inserted. In this case, you can see by the reflection (white arrows) the sheet metal has been bent down by the hook during installation. This will not allow the hook to fully seat properly under the metal lip and needs to be corrected.
