**SUBJECT****During Engine Oil Service a Small O-Ring Is Found in the Oil Filter Housing****MODEL**

All vehicles produced from start of production to December 2011

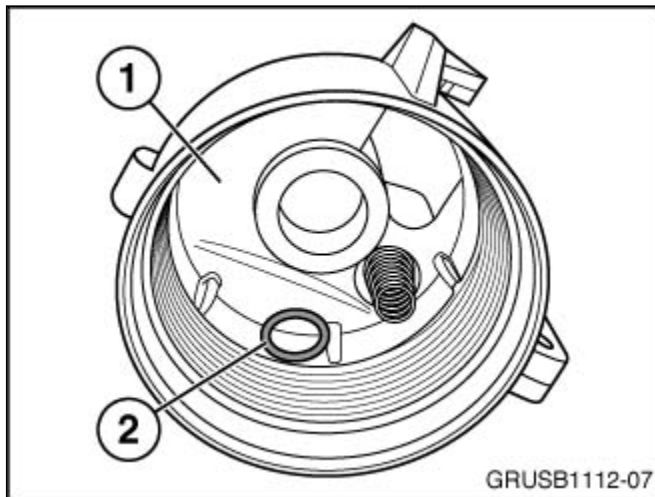
No customer complaint has been received. During the scheduled engine oil service, the technician notices a black rubber o-ring lying on the bottom of the engine oil filter housing. The o-ring has been dislodged from the non-return valve inside the engine oil filter housing. No subsequent engine damage occurs from the dislodged o-ring.

Engine oil filter housing (1)
Rubber o-ring (2)

The material dimensions of the rubber o-ring are not satisfactory, allowing it to become dislodged from its installation location.

If the o-ring is found in the engine oil filter housing, the entire engine oil filter housing must be

replaced.
