This Service Information bulletin supersedes SI M51 08 12 **dated August 2012**.

Rattling Noise from the Tailgate

R58

Produced from August 2011 to July 2012

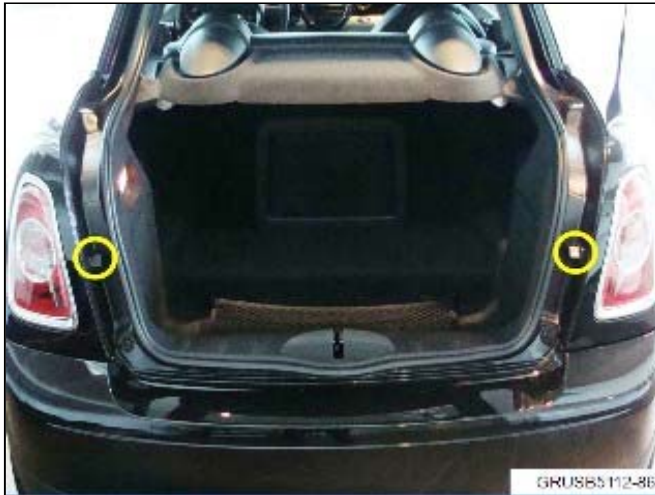
1. Open the tailgate and locate both lower rubber bump stops.

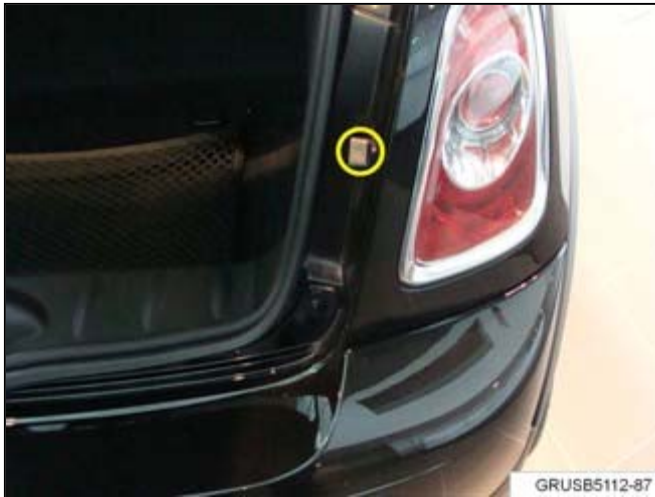
2. If the felt tape on the bump stop is mis-shaped or missing, it must be replaced.

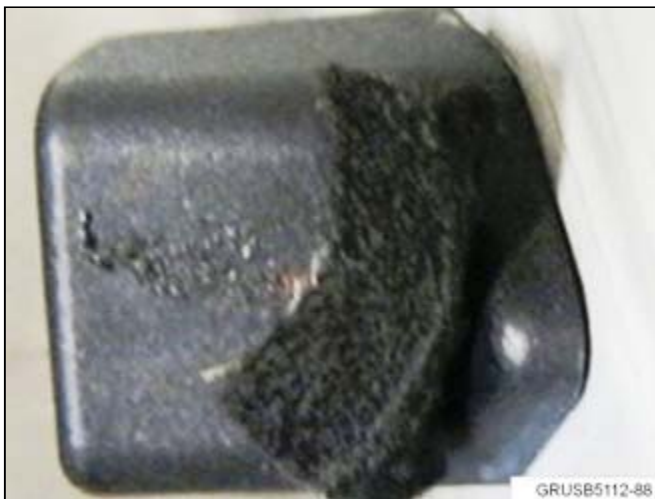
The felt strip on the lower bump stop is either mis-shaped or missing.

3. This close-up view shows the existing felt is mis-shaped and it will eventually fall off.
