US 49881318-03

**Subject**Charger - malfunctions when charging battery on K1600  
GT/GTL**Status date (mm/dd/yy)**

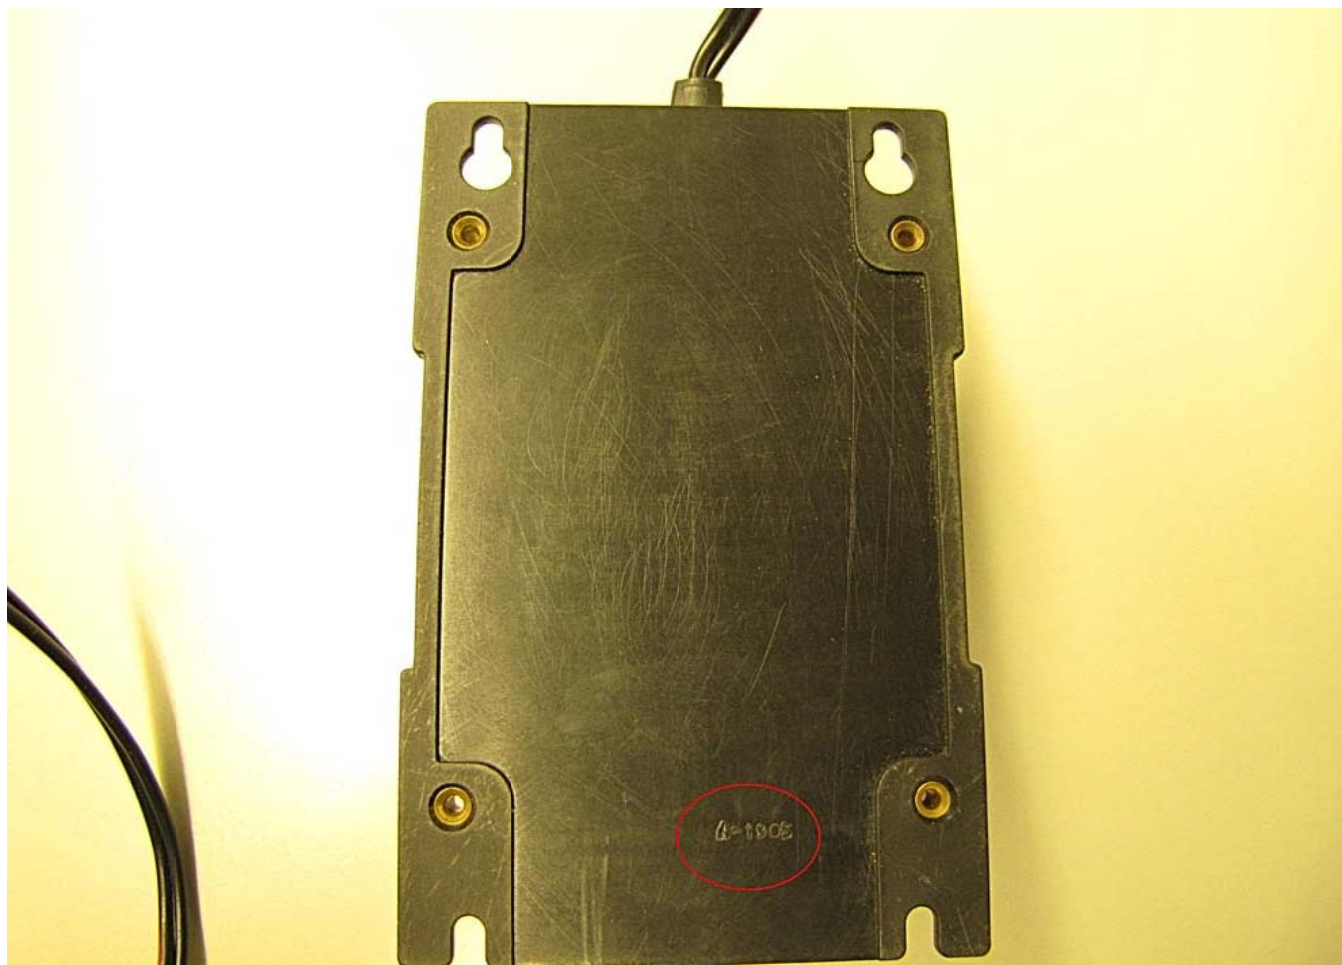
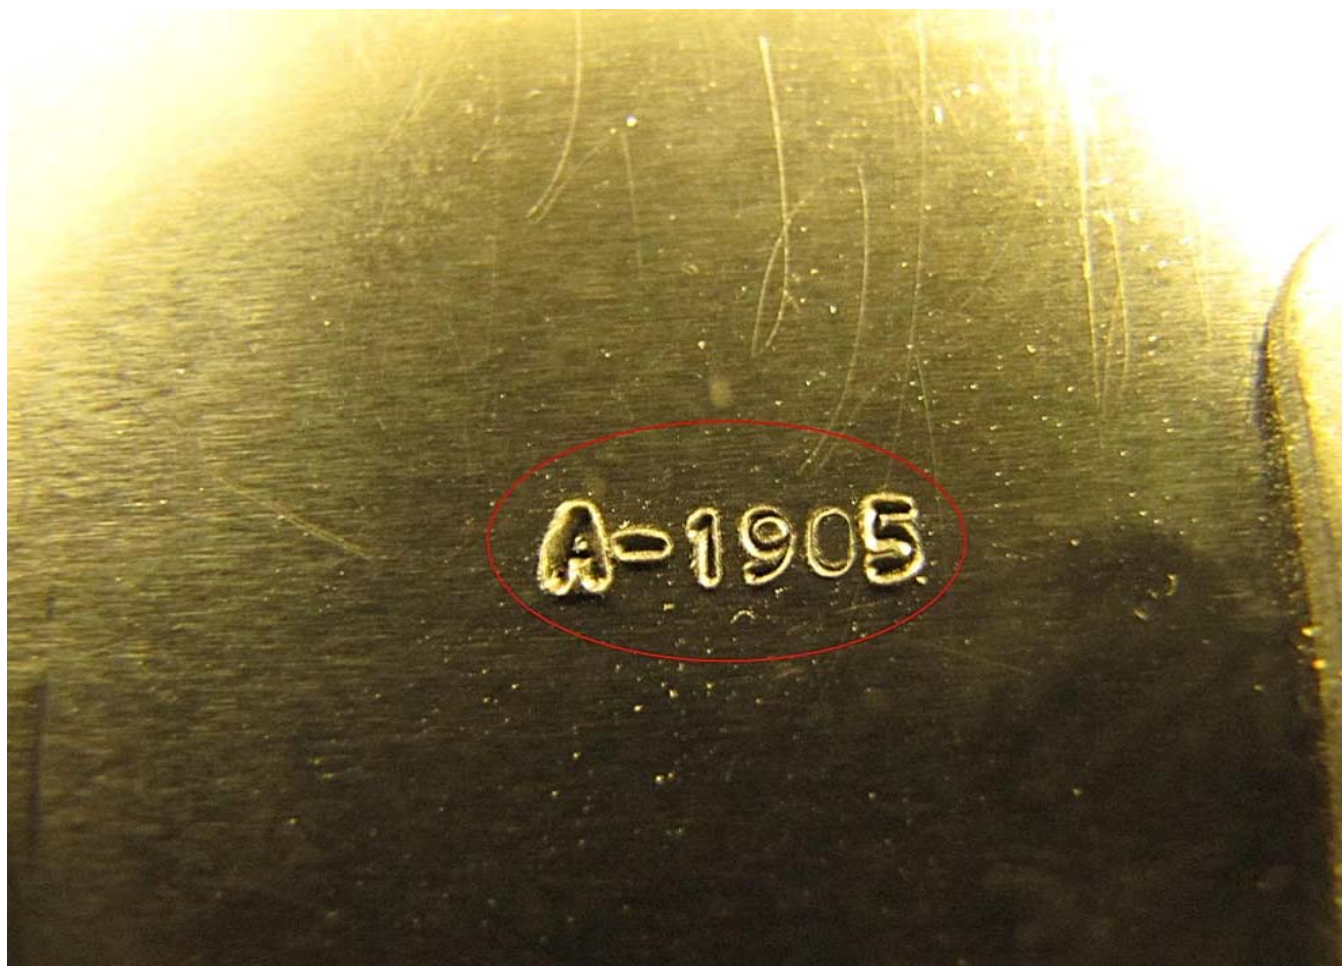
\*) The date of manufacture can be found on the charger's black base plate. The code "A-3205" means calendar week 32, year 2005. Further information regarding the location of the manufacturing code can be seen pictured in the attachment.

Check the charger's date of manufacture (refer to the information in the attachment). From date of manufacture A-3405, no malfunctions occur on the charger.
