Rear Park Distance Control Does Not Work

E84

Produced to September 10, 2012

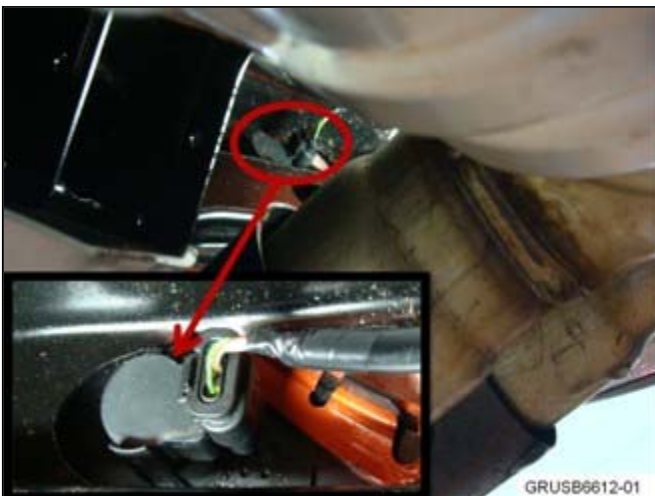
4. Locate the driver's side rear outer PDC sensor.
5. Uninstall the PDC sensor from the mounting bracket in the bumper as per Repair Instruction 66 20 534, “Removing/replacing left rear outer PDC sensor.”

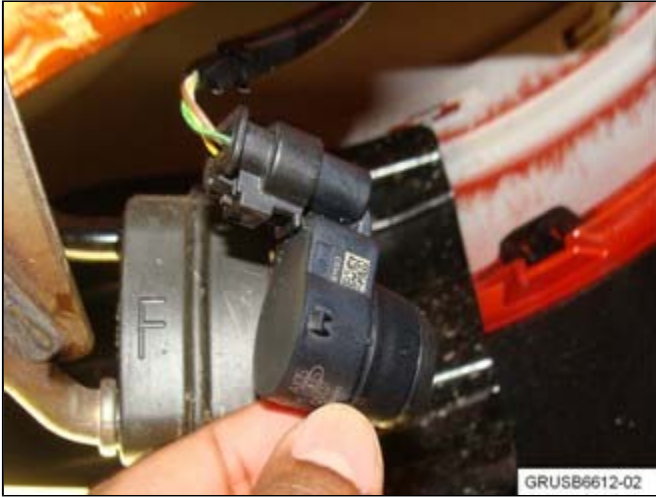
6. Disconnect the sensor from the wiring harness.
7. Check the connectors on both the wiring harness and the PDC sensor for dirt and corrosion. Clean both connectors.

Note: If pins are corroded and cannot be cleaned, replace as needed.

8. Reconnect the PDC sensor and retest the rear PDC functionality.
