## Aftersales Bulletin

Area **Service Information**  
Subject 00 61 72 03 00 – KIT 10 Phantom Series II Aviator Edition Tunnel Finisher  
Group 00 61  
Reference 00 11 12  
Published date 04 December 2012  
Version 1  
Department Service Operations/OH  
Recipients All Service Managers, Aftersales Managers and Service Technicians of Rolls-Royce Motor Cars Dealers

Rolls-Royce Phantom Series II Aviator Edition models produced between 26.10.2012 and 30.10.2012 have been built with incorrect fixings in the transmission tunnel finisher. To maintain our high levels of quality and customer satisfaction, Rolls-Royce Motor Cars has decided to replace the fixings on all affected vehicles.

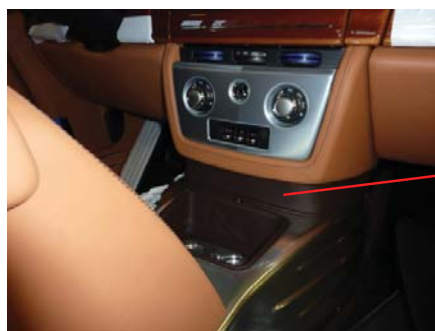
Photo 1: Trim location

- 2.1 Use the KIT search function in S-gate or ISPA to verify if this Service Action is outstanding on any vehicles booked into your workshops.
- 2.2 Remove both front seats following ISTA repair instructions "52 14 000 Removing and installing left or right front seat".
- 2.3 Remove centre console following ISTA repair instructions "51 16 ... Removing and installing/replacing centre console (front)".
- 2.4 Remove trim between bottom of A/C control panel and top of transmission tunnel (Photo 1) by inserting the trim tool and then unclipping and removing trim (Photo 2).

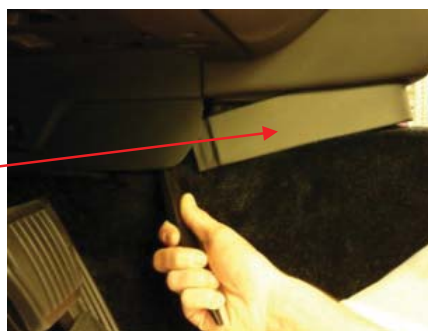
Photo 2: Trim tool to unclip and remove

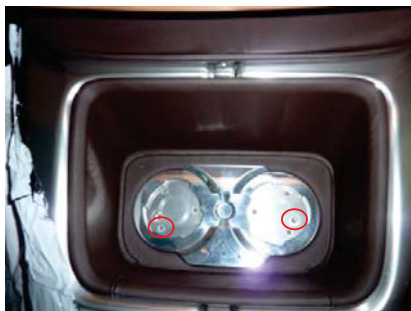
Photo 3: Cup holder fixings

- 2.5 Remove cup holder by unclipping then lifting out cup holder insert to reveal two fixings securing cup holder carrier. Unscrew both fixings (Photo 3) and lift out cup holder carrier.

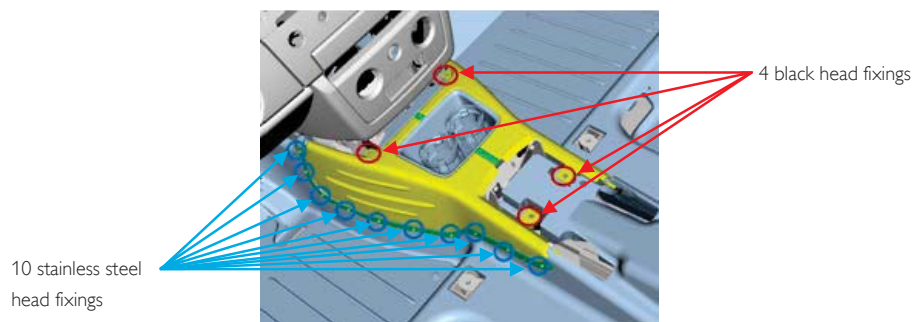
Photo 4: Aluminium tunnel fixings

- 2.6 Remove the aluminium tunnel finisher by unscrewing 4 black head fixing screws on the top surface of tunnel finisher and a further 10 stainless steel fixing screws on both sides of the tunnel finisher (Photo 4).

**Note:** Re-torque the 4 black head fixing screws on the top surface of tunnel finisher to 7.6Nm and the 10 stainless steel head fixing screws on both sides of the tunnel finisher to 1.5Nm during reassembly.

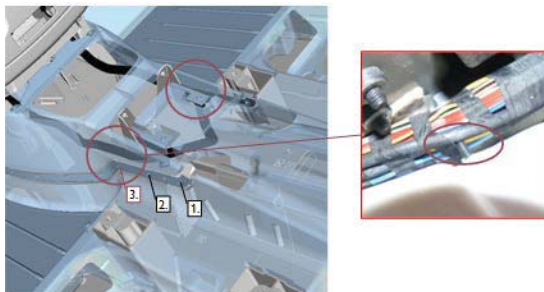
Photo 5: Damage points in wiring harness

- 2.7 Fold back carpet to reveal the wiring harness and then unclip the wiring harness from the body and check the wiring harness for damage at three points (Photo 5).

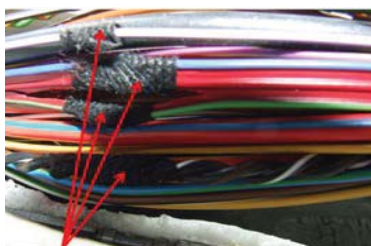
Photo 6: Add extra electrical tape at the damage points

- 2.8 Add extra electrical tape at the damage points on the wiring harness (Photo 6).

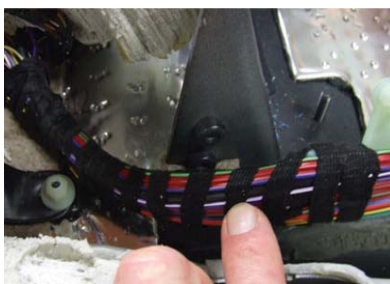
Photo 7: Lay harness in correct position and clips in correct orientation

- 2.9 Lay the harness in the correct position with all clips in the correct orientation before beginning the next step (Photo 7).

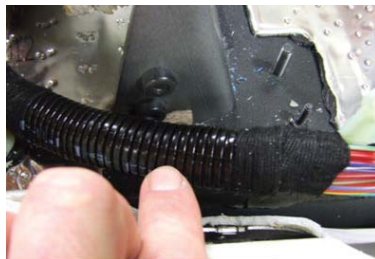
Photo 8: Corrugated tube to cover the damage points

2.10 Fit corrugated tube over the harness to cover the damage points (Photo 8).
