This Service Information bulletin supersedes SI M12 02 10 **dated November 2012.**

Cooper S with N14: Diagnosis for Misfire Faults

R55, R56, R57, R58 and R59 with the N14 engine

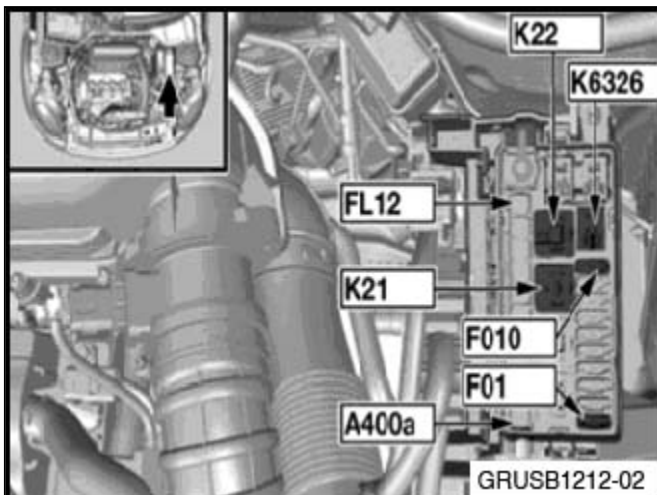
Locate the front power distribution box (A400a)

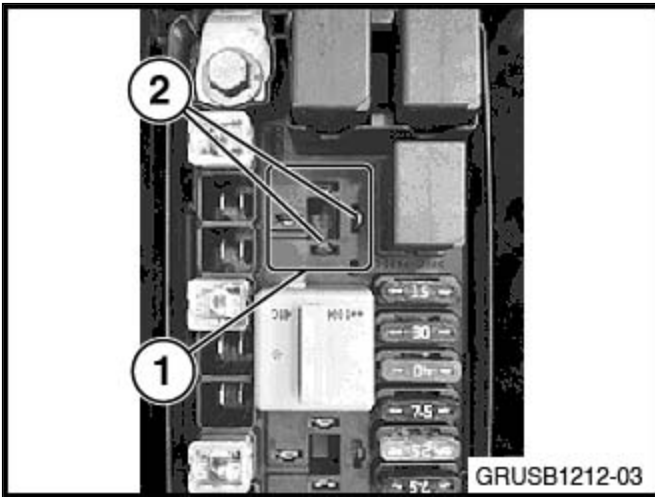
Connect battery charger
 Remove electric fan relay K22 (1)
 Insert Special Tool P/N 61 31 1 379
 817 to activate the cooling fan. Make
 sure that the contacts bridge the two

terminals shown in the illustration (2). The tool will activate the fan by connecting terminal 87 and 30 of the relay connector. For additional information refer to SI M04 14 12. The cooling of the engine requires approximately 2 hours.
