This Service Information bulletin supersedes SI M17 04 12 **dated October 2012.**

Service Action: Retrofit of the Engine Coolant Temperature Sensor

R60 with manual transmission (N16 or N18 engine)

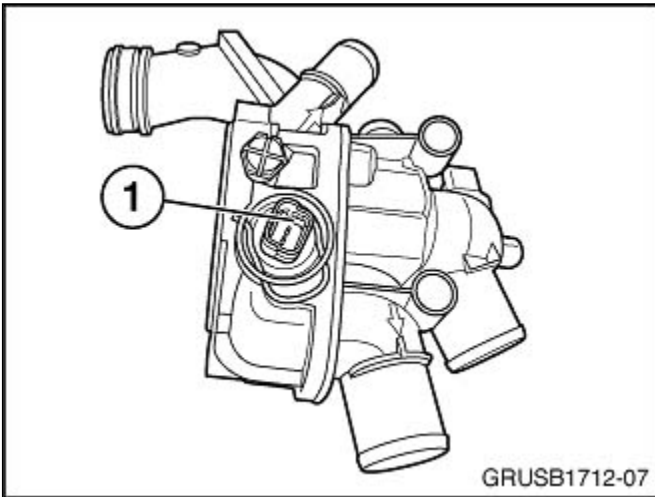
Checking for updated thermostat: The 11 53 7 534 521 thermostat has a replaceable engine temperature sensor (1).
