This Service Information bulletin supersedes SI 17 05 12 **dated October 2012.**

**Service Action: Retrofit of the Engine Coolant Temperature Sensor**

R60 with automatic transmission (N16 or N18 engine)

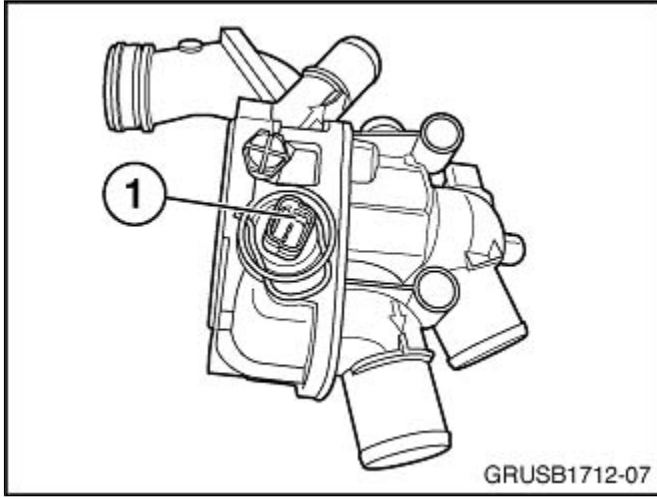
Checking for the updated thermostat:  
The 11 53 7 534 521 thermostat has a replaceable engine temperature sensor (1).

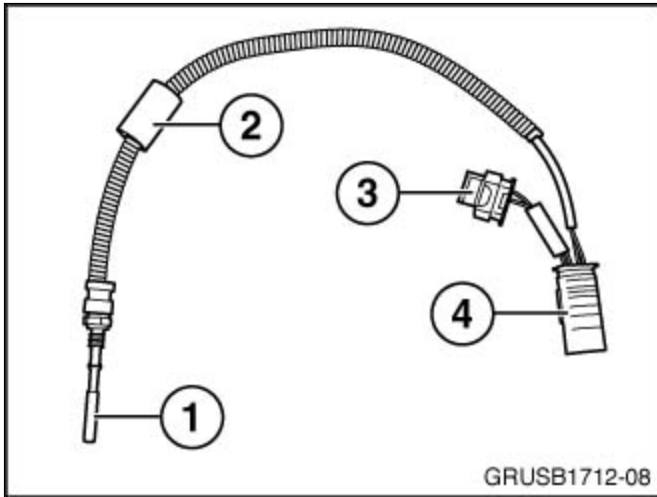
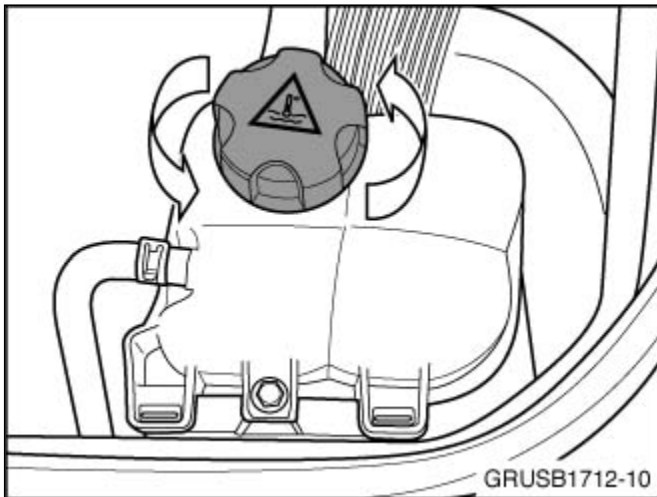
The improved sensor (P/N 13 62 8 603 908) includes the temperature probe (1) and insulating sleeve (2), a two-pin female connector (3) for the map thermostat, and a four-pin connector (4) for the engine harness.
