This Service Information bulletin supersedes SI M17 06 12 **dated October 2012**.

**Service Action: Retrofit of the Engine Coolant Temperature Sensor**

R55

All with manual transmission and either the N14, N16 or N18 engine

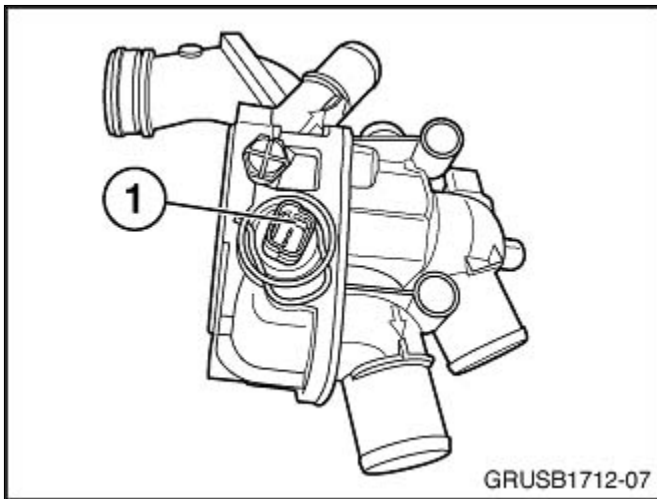
Checking for the updated thermostat:  
The 11 53 7 534 521 thermostat has a replaceable engine temperature sensor (1).

- Replace the engine wiring harness with the 11 53 7 534 521 thermostat.
- Do not install the remote engine temperature sensor. Claim the labor operation “Check for 11 53 7 534 521 thermostat installation” in the Warranty Information section of this bulletin.
- Affix the Service Action label to the B-pillar.
