SUBJECT**Front Power Windows Not Functioning Properly****MODEL**

R60

Produced from July 31, 2010 to October 17, 2012

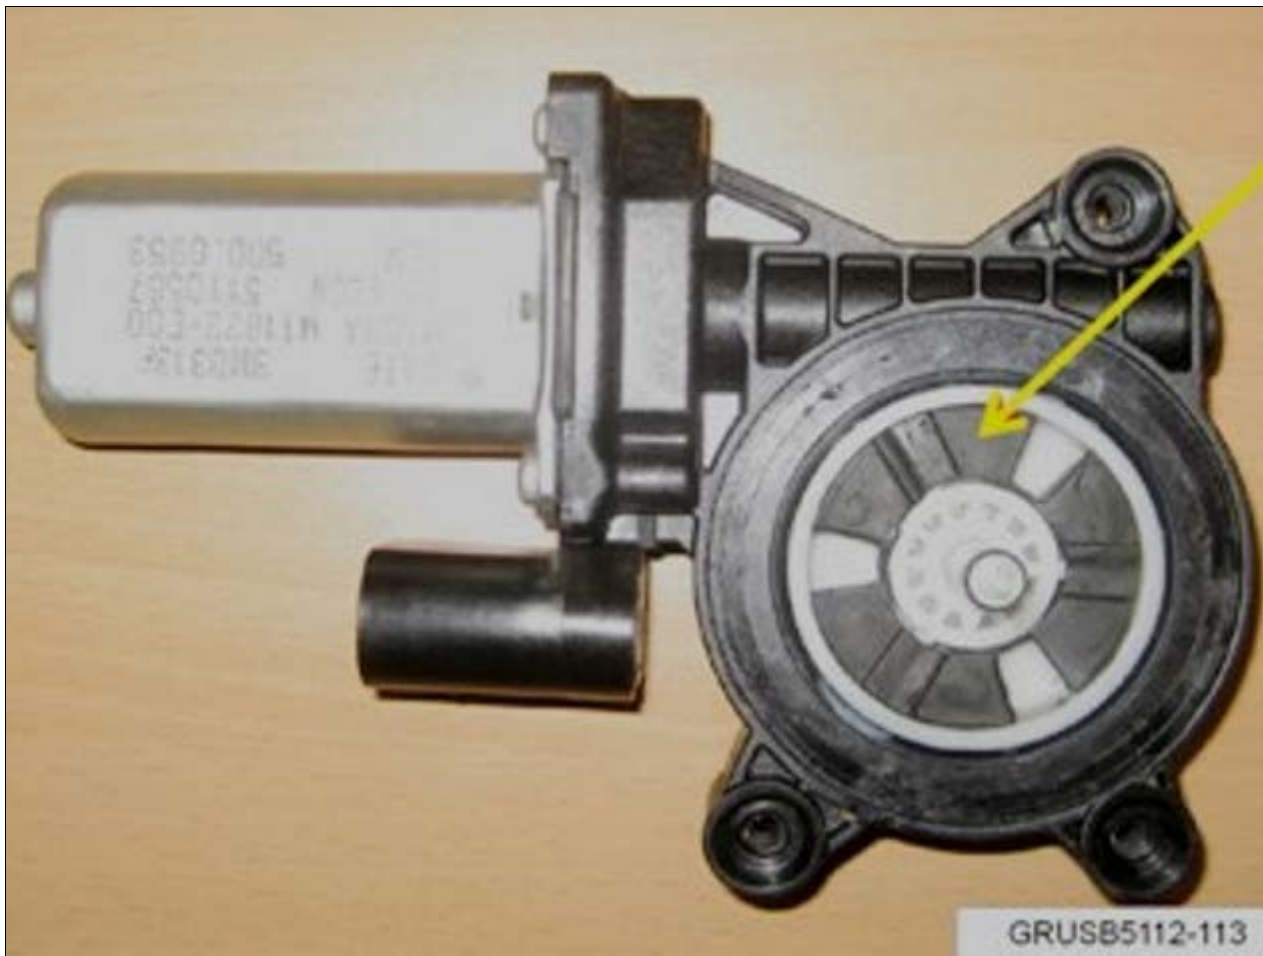
Important Note: When installing the new motor, **ensure the rubber coupling from the faulty motor is removed (see the arrow in the illustration below) and reinstalled into the new motor drive.**

Note: The rubber coupling is **NOT** supplied with the new window motor.

1. For vehicles produced prior to August 30, 2012, replace the affected power window motor(s), using the appropriate part number below. Refer to ISTA Repair Instruction 51 33 000.
