SI M62 01 12
Instruments

December 2012
Technical Service

Service Action: OBC Functions Missing - Retrofit Procedure

R60

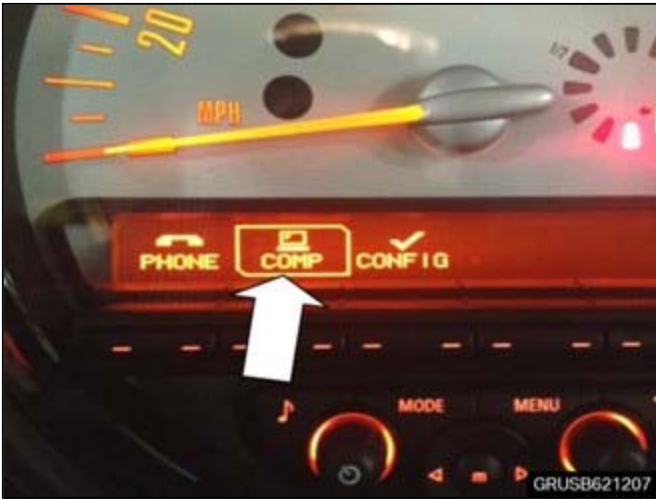
1. If the “COMP” selection is available in the display below the speedometer, no further action is required. If the “COMP” selection is missing, proceed to the next step.

2. Submit a PuMA case to Technical Service requesting a modified Vehicle Order with option code 550 added. An IBAC code is no longer needed if ISTA/P 2.48.2 or later is used.
3. Once the Vehicle Order is obtained via PuMA, download it onto a USB device for import into ISTA/P 2.48.2 or later.
4. Import the VO into ISTA/P and select complete car coding.

5. After the coding has successfully finished, switch to ignition off for 5 minutes.
6. Switch the ignition back on and check to see if the “COMP” selection is now available as described in step 1.
