2011FA06  
May, 2012  
Product Code(s): 71  
Page 1 of 13

SUBJECT: H 40/50 EP™ Suction Filter Update For Nova Buses Field Action

MODELS AFFECTED: H 40/50 EP™ Drive Units installed in Nova buses

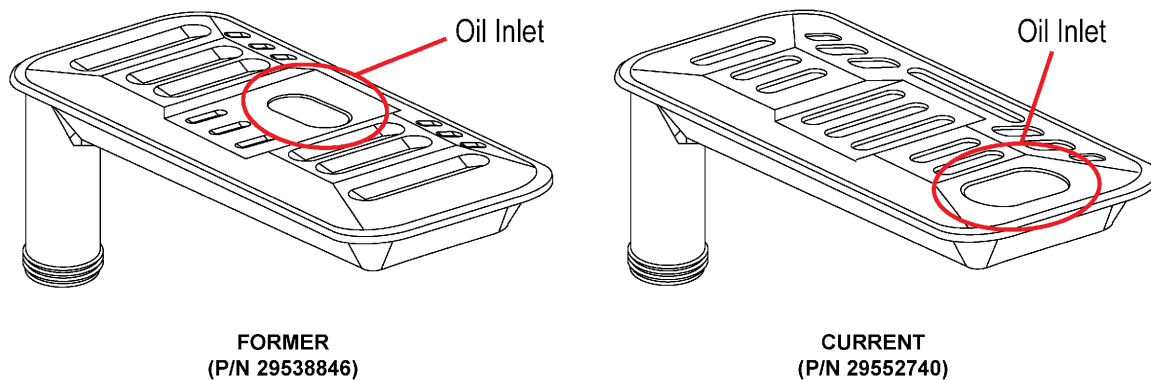
**Figure 1. Fluid Suction Filter (H 40/50 EP)**

Allison Transmission, Inc. has identified a potential concern with Nova buses where the H 40 EP Drive Unit™ or H 50 EP Drive Unit™ is installed at a front to back slope of 8.0 degrees or more downward toward the output end of the Drive Unit. The suction filter has been redesigned with the opening rotated 90 degrees and moved toward the output end of the Drive Unit. Refer to [Figure 1](#). Previous instructions to add fluid until the OLS reading was “oL, HI, 02” (2 quarts/liters high) to prevent the suction filter opening from being uncovered resulting in air being drawn into the system are eliminated upon completion of this repair.

The parts required for this Field Action are to be ordered individually and are listed in [Table 2](#).

1. Clean the exterior of the oil pan to avoid contamination during disassembly.
2. Remove the drain plug and drain the fluid.
3. Remove the four (4) M8 x 1.25 x 70mm bolts that retain the filter cover.
4. Remove the filter cover and discard the o-ring.
5. Remove the filter.
6. Remove the thirty-two (32) M8 x 1.25 x 30mm bolts and the four (4) M8 x 1.25 x 75mm bolts that retain the oil pan.
7. Remove the oil pan and discard the gasket.
8. Remove the two (2) M6 x 1 x 60mm bolts from the two (2) retaining clips that retain the suction filter.
9. Remove the two (2) clips that retain the suction filter (P/N 29538846) and remove the suction filter and seal.

10. Install the new suction filter and seal, P/N 29552740.
11. Install the two (2) clips that retain the suction filter.
12. Install the two (2) M6 x 1 x 60mm bolts into the two (2) retaining clips.
13. Torque the bolts to 10-13 N·m (7-10 lb ft).
14. Install oil pan with new gasket and finger tighten the thirty-two (32) M8 x 1.25 x 30mm bolts and the four (4) M8 x 1.25 x 75mm bolts.
15. Install the new lube filter with a new o-ring.
16. Install the filter cover and finger tighten the four (4) M8 x 1.25 x 70mm filter cover retaining bolts.
17. Torque the oil pan and filter cover retaining bolts to 24-29 N·m (18-21 lb ft).
18. Install a new o-ring on the drain plug and install the drain plug and seal assembly in the oil pan.
19. Torque the drain plug to 24-32 N·m (18-24 lb ft).
