Technical Bulletin

92 12 04 November 2, 2012 2024878 Supersedes T.B. V921201 dated January 17, 2012 to add additional model year applicability.

Wiper Blade Inspection for Proper Warranty Coding

Wiper blade inspection guidelines for wear and tear, outside influence and factory defect.

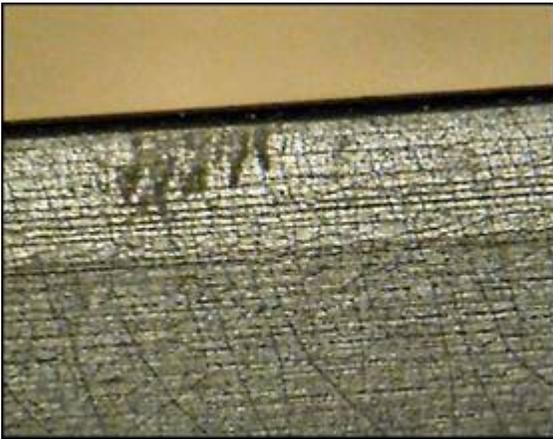
Figure 1

Worn wiper edges.

Wiper rubber insert dried out, hardened and cracked (figures 1 and 2).

Conditions in Figures 1, 2, 3 are considered wear and tear and are limited to 6 months/6,000 miles, whichever occurs first.

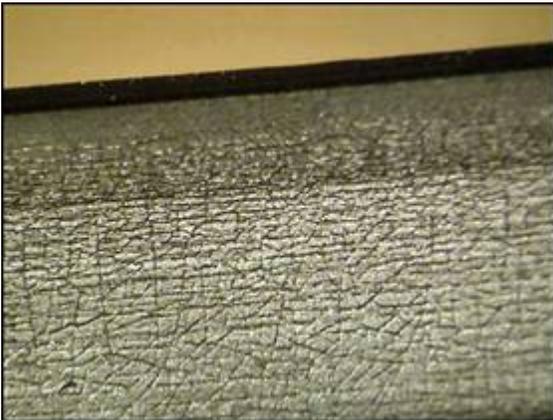
Figure 2

Wipers exposed to extreme hot or dry weather conditions can dry out and harden wipers over time.

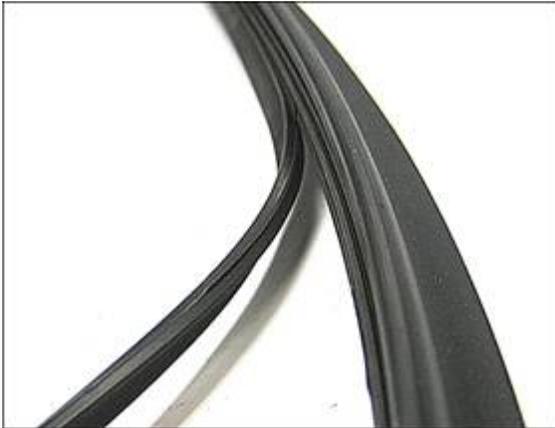
Figure 3

Wiper blade torn or insert separated.

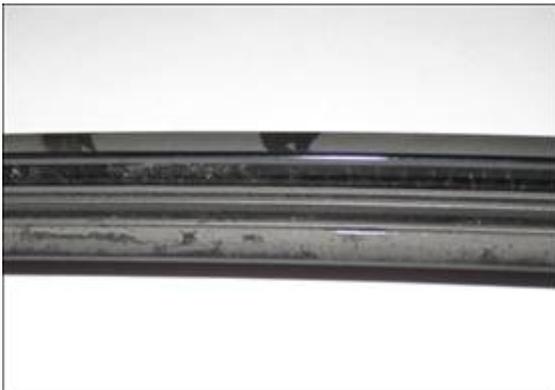
Figure 4

Contamination

Wiper blades found with contamination of tree sap, dirt and debris, wax, windshield Nano coatings, or any other substance are not covered under warranty.

Refer to technical bulletin instance 2026253 (USA) or 2018568 (Canada) for proper windshield inspection and cleaning before wiper blade replacement occurs.

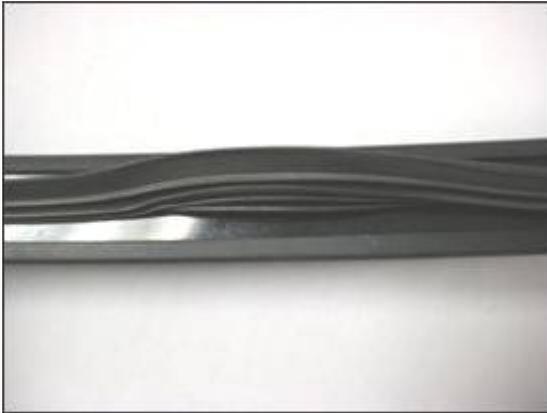
Figure 5

Wiper insert pulled from guides

Wiper insert separating from guide.

This is usually due to the wiper blade being frozen to windshield, damaged from ice scrapers, or any other object used to free wiper blade.

This is not a factory defect if not identified at time of PDI.

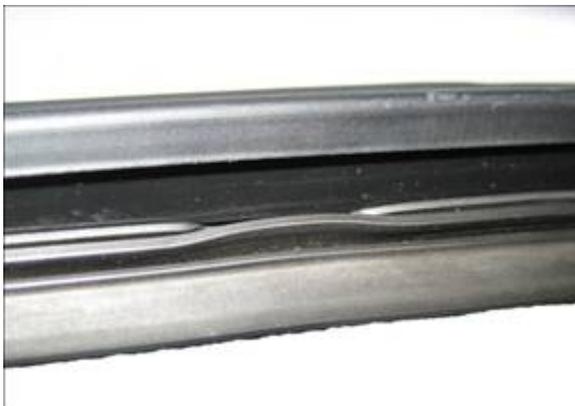
Figure 7

Wiper pinched inside guide retainers

Wiper blade is pinched between retainers during assembly.

Wiper blades should be inspected for factory defects at time of the PDI.

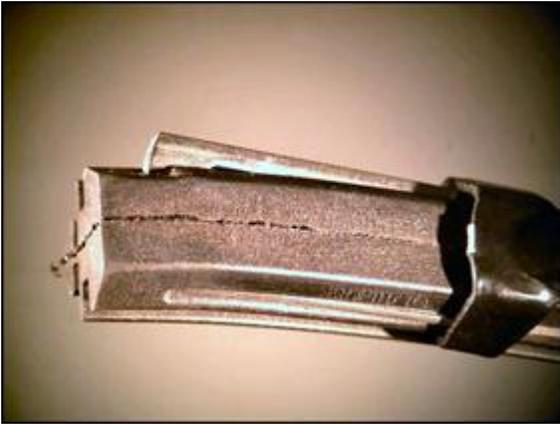
Figure 8

New Beetle / New Beetle Convertible wiper insert retainer coming out

Due to incorrect wiper arm attack angle adjustment from the factory.

Condition can only be corrected by adjusting wiper arm attack angle using Special Tool #3358B.

Refer to Elsa Web/Repair Manual/ Maintenance/ Maintenance Procedures/ Wind shield Wiper Blades, Checking End Position and Angle.
