TT7101EN  
May, 2012  
Page 1 of 2

SUBJECT: Leaking/Cracked 1000/2000 Product Family Torque Converter

MODELS AFFECTED: International 4200, 4300 Trucks Equipped with DT466 Engines and Ford F650, F750 Trucks Equipped with Cummins 6.7L Engines.

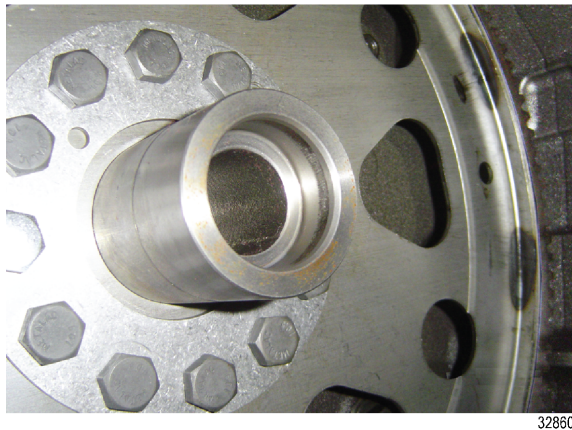
- Result of torque converter pilot being forced against one side of the crankshaft hub bore
- Misalignment during installation

**Figure 1. Crankshaft Hub Bore (Damaged)**

- Verify that the fluid leak originates from the torque converter pilot by conducting a Torque Converter Leak Test as described in 1000/2000 Product Families Service Manuals (SM5818 or SM4006).
- Identify area of crack on torque converter pilot with paint marker or Dykem®.
- Notify your OEM Field Service Representative to initiate discussion and receive compensation.
- Notify Allison TAC at 1-800-252-5283 to open a case and record the appropriate information.
- Photograph the torque converter pilot (showing crack) and inside diameter of crankshaft hub bore. Send pictures of the damaged areas to Allison TAC, so they can be attached to your case. Refer to [Figure 1](#) and [Figure 2](#).
- Remove and inspect the charging pump for damage if the torque converter pump drive hub is damaged.
- Replace original torque converter with a new assembly.

- Install and finger-tighten one adapter bolt.
- Rotate the engine 180°.
- Install and finger-tighten another adapter bolt.
- Install and finger-tighten all remaining adapter bolts.
- Torque all of the flexplate-to-flexplate adapter bolts to OEM or Engine Manufacturer specification.

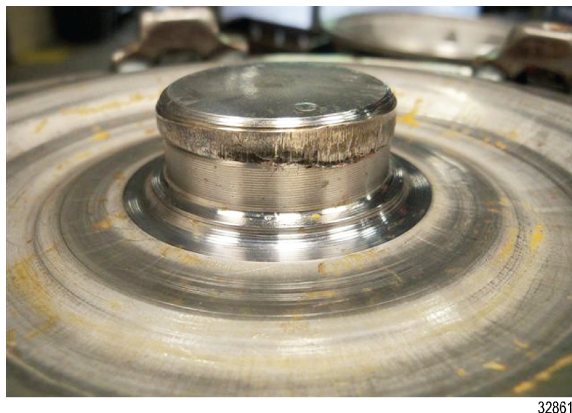
Cracked torque converter pilot:

**Figure 2. Torque Converter Pilot (Damaged)**
