# UPDATE Technical Bulletin

91 12 21 October 05, 2012 2031133

UPDATE – 91J7 RCD 510 (Premium 8) Radio Software (U.S. Only)

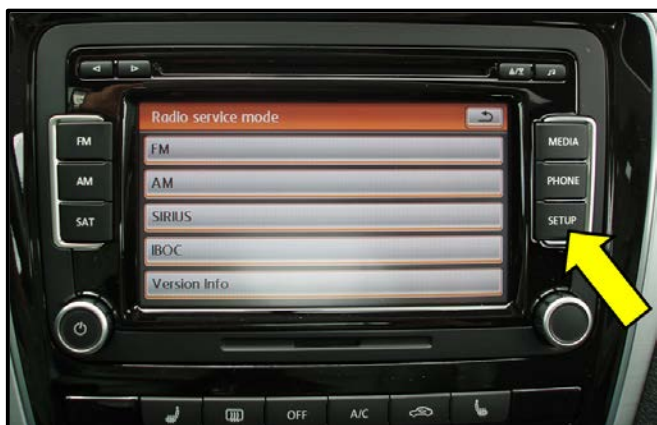
- ⇐ On the radio, hold "setup" button <arrow> for 3 to 5 seconds.
- "Radio service mode" will display <as shown>.

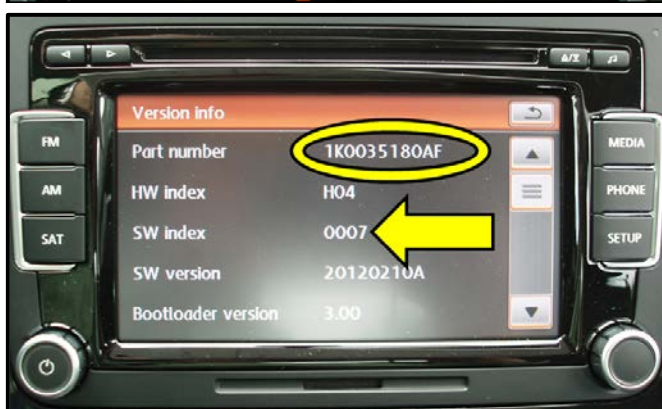
- ◀ Verify current part number is **1K0-035-180-AF** <circle>.
- ◀ Verify current SW index is “0007” <arrow>.

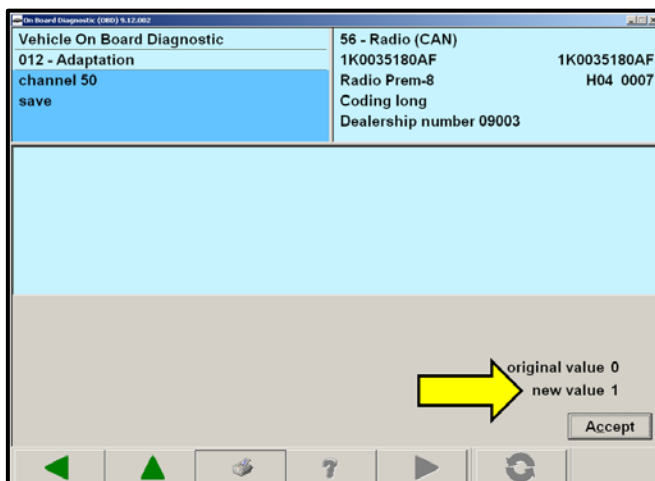
- Using VAS tester, enter Vehicle Self Diagnosis => 56-Radio => 012-Adaptation.
- Enter channel number “50” using keypad, then select “Q”.
- ◀ Change the value to “1”, then select “Save”.
- ◀ Verify “new value” equals “1” as shown <arrow>.
- ◀ Select “Accept”.

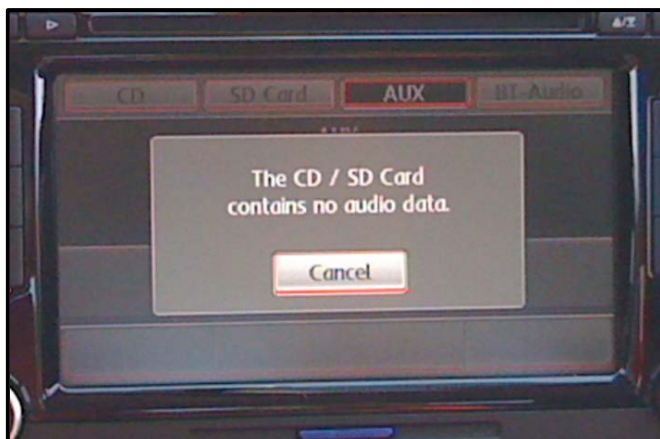
If a message “The CD/SD Card contains no audio data” <as shown appears when SD card is inserted, repeat previous steps due to adaptation not correct.

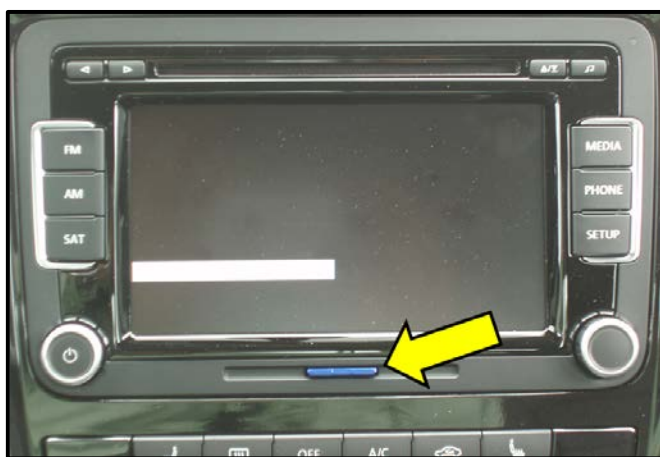
⇐ Insert the SD card# PREM8 RADIO SW08 into the SD card slot on the radio as shown <arrow>.

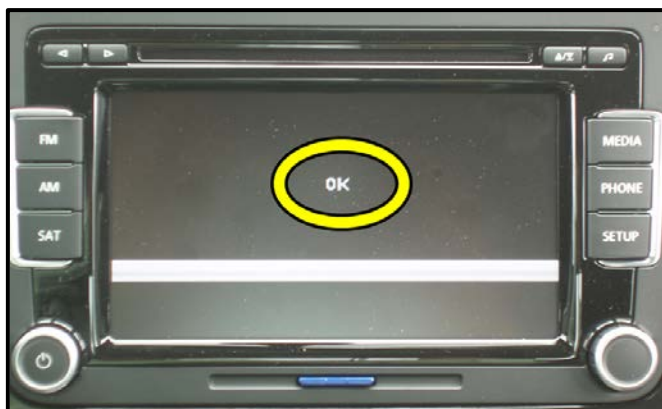
⇐ When update is complete, "OK" <circle> will appear on screen.

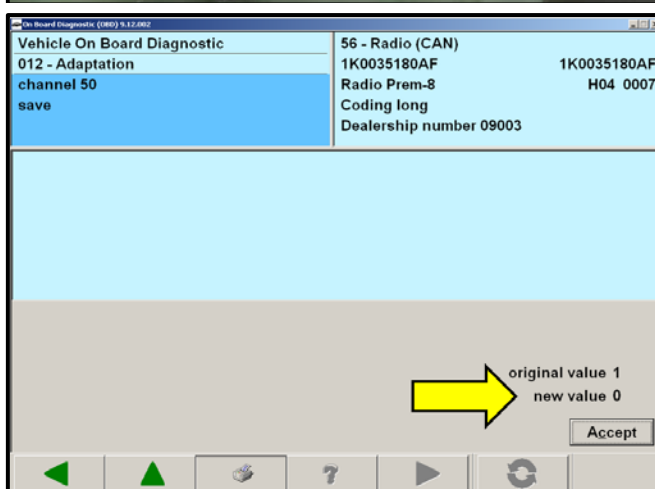
- Using VAS tester, enter Vehicle Self Diagnosis => 56-Radio => 012-Adaptation.
- Enter channel number "50" using keypad, then select "Q".
- ⇐ Change the value to "0", then select "Save".
- ⇐ Verify "new value" equals "0" as shown <arrow>.
- ⇐ Select "Accept".
- Clear any relevant DTCs.
- Remove VAS tester and battery charger from the vehicle.

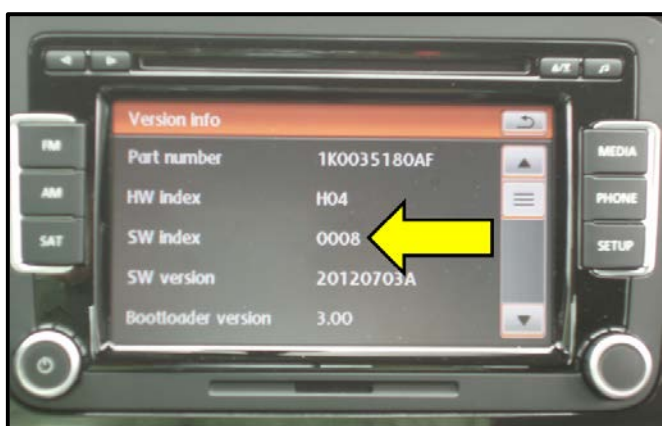
- Cycle ignition key OFF, then back ON.
- Press and Hold the "Setup" button for 3 to 5 seconds.
- ⇐ Verify new "SW index" is "0008" as shown <arrow>.
