# UPDATE Technical Bulletin

October 09, 2012 2011164

## UPDATE – 96C7 Micro Switch for Oil Level (NVLW)

Model(s)	Year	Engine Code	Trans. Code	From	To
Passat	2012 - 2013	CDVB	All	1VW_M_A3_C_000165	1VW_M_A3_D_015433

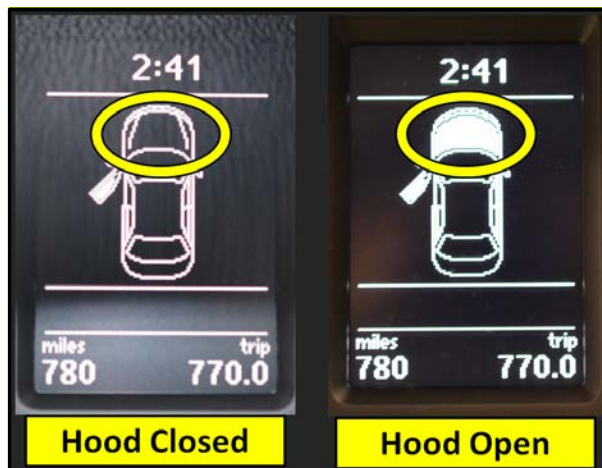
- Open the hood.
- ◀ Check the MFI to see if the indicator indicates Hood Open <as shown>.
- If the MFI indicates Hood Open, WORK COMPLETE.
- If the MFI DOES NOT indicate Hood Open, continue work procedure.
