## REPAIR DOCUMENT

### Ag Hopper Trailer Coupler to Hopper Structure Upgrade

Repair Document #: **RD-00031**

Date: August 22, 2012

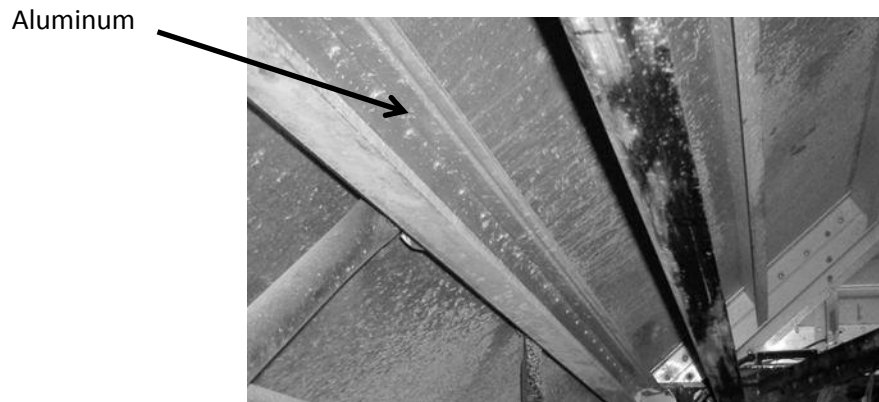
STOUGHTON trailers covered by this document are Model Year 2009 and 2010's that have an aluminum crossmember on the forward side of the front hopper (Fig 3). The aluminum crossmember and the steel crossmember forward of that will be removed along with part of the steel side channels inside the bottom rail. This will be replaced by a new sub-assembly that includes an integral full width shear plate between the two crossmembers. Doubler plates will be added on the outside of the bottom rails. The 3/8" Huck fasteners attaching the diagonal brace channels between the hopper and the upper coupler will be replaced with 1/2" bolts. Gussets will be added to the aft corners of the coupler.

Figure 3: Early unit with Aluminum crossmember by landing gear.

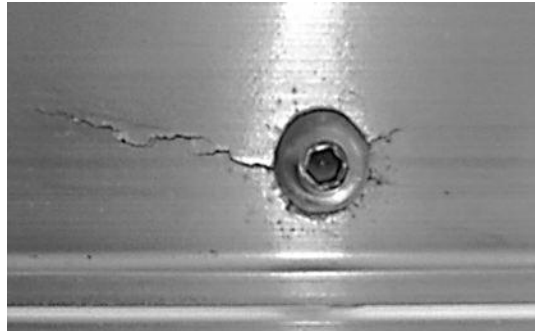
#### **1. Cracks in the bottom rail around bolts and at the inside corner of the bottom bulb.**

- a. Bottom rails on both sides of the trailer must be inspected from 3 ft. in front of the landing gear to 2 ft. behind the landing gear.
- b. Look for cracks around the fasteners.
  - Spider web cracks generally extending horizontally (Fig. 4)
- c. Look for cracks on the top inside corner of the bottom bulb. (Fig. 5)
  - If crack on inside corner extends outward on the horizontal leg of extrusion and is closer than 3/8in from the outside face of the bottom rail then contact Stoughton Trailers Customer Service to determine if bottom rail must be replaced.
- d. Doubler plates will be installed on the outside of the bottom rail in this area to correct for these issues

Figure 4: Spider crack on bottom rail

- e. Record location and severity of any cracking found on a unit in issued paperwork and report this information to Stoughton Customer Service.

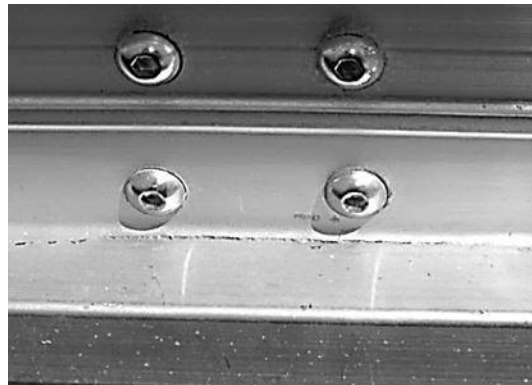
Figure 5: Crack on the top inside corner of bottom bulb.

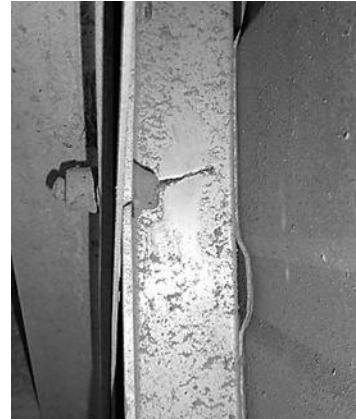
**2. Cracked side posts at bottom of front hopper slope**

- a. Inspect 3 side posts that are exposed forward of the front hopper. The cracks most commonly occur inside the side extrusion (Fig 6).
- b. Inspect for crack at rivet connecting the bottom edge of hopper slope.
- c. Inspect for crack at bottom of post inside corner between web and flange where it connects to bottom rail.
- d. See Appendix A for repair procedure

Figure 6: Crack on side post by front hopper slope.

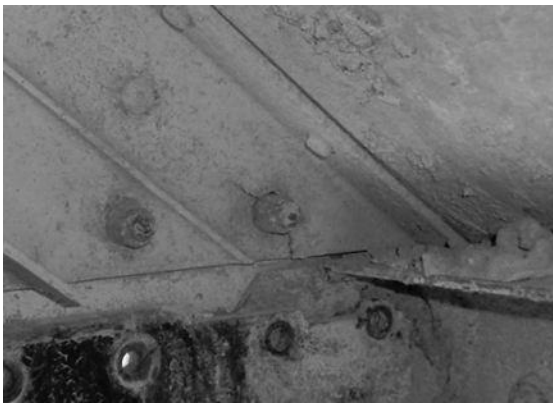
**3. Cracked forward slope side extrusion at bottom of front hopper.**

- a. Inspect for cracks in extrusion (Fig 7).
- b. See appendix A for repair procedure.

Figure 7: crack on side extrusion.

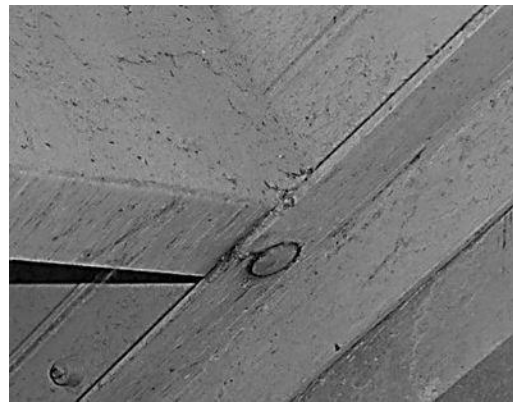
Figure 8: Cracks at side extrusion and Z plate connection.

**4. Cracked forward slope side extrusion where attached to Z crossmember in front of forward hopper.**

- a. Inspect for cracks in extrusion (Fig 8).
- b. Look for loose fasteners
- c. See Appendix A for repair procedure.

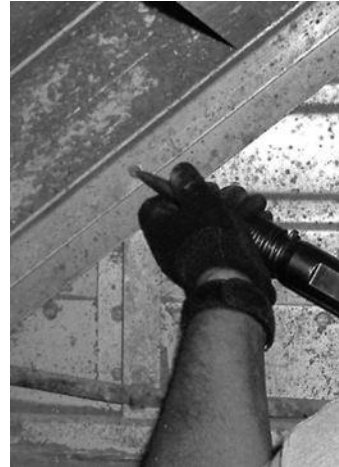
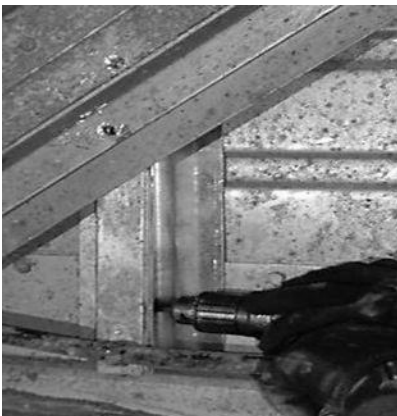
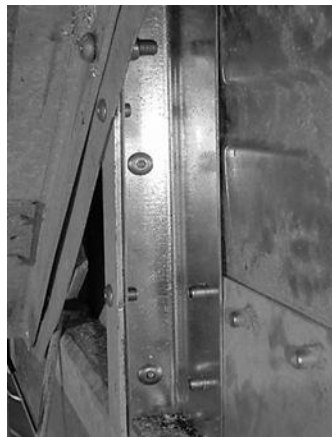
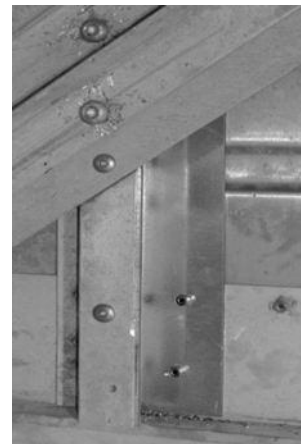
Repair procedure for all trailers found to have cracked side posts at bottom of front hopper slope.  
(Inspection #4).

1. Disconnect wiring and pull it out of broken post.
2. Remove the lower two (2) fasteners connecting the forward slope side extrusion to the side post (Fig. A1).
3. Remove the fastener at the top of the rail adjacent to the post.
4. Push side post reinforcement plate (SK-07770) into place.
  - a. Use a hammer to ensure the reinforcement plate is all the way back against the broken side post.
5. Drill holes from:
  - a. Reinforcement plate to broken side post, one toward the bottom and one toward the top (Fig. A2 & A3).
  - b. Outside bottom rail into reinforcement plate and one (1) additional 1" below.
  - c. Inside forward slope side extrusion into reinforcement plate
6. Fasten the reinforcement plate into place (Fig. A3 and A4).
7. Reconnect Wiring

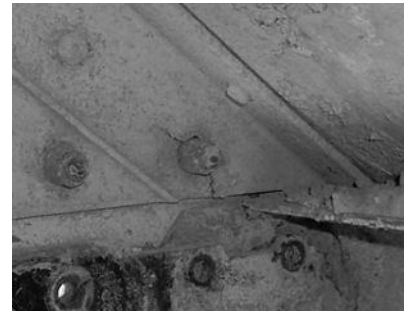
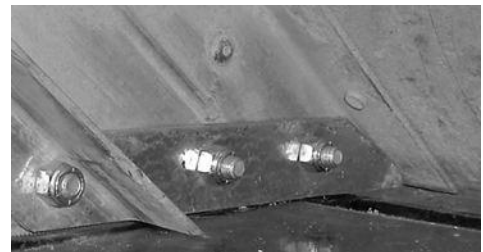
Repair procedure for all trailers found to have cracking on the forward slope side extrusion rail at rivet. (Inspection #5).

1. Remove approximately 1.5" of the rib at the bottom of the slope extrusion.
2. Clamp the reinforcement bracket on the flat part of the rail
  - a. Ensure that it cannot move
3. From the outside of the trailer use the existing holes in the rail to drill thru the reinforcement plate.
4. Fasteners will be installed during the upgrade procedure (Fig. A6).

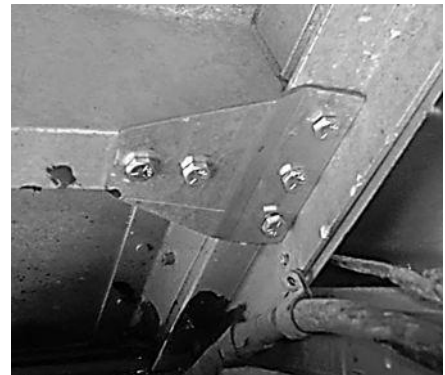
Figure A7

Repair procedure for all trailers found to have cracking or loose fasteners on the Z post (Inspection #7).

1. Remove the rivet attaching the side extrusion to the Z crossmember, where crack has occurred.
2. Place the repair clip in position over crack and install a single bolt through the Z post, side extrusion, and repair clip.
3. Ensure that the clip is properly aligned with the Z post.
  - a. Tighten the lock nut to stabilize the repair clip to the Z post.
4. Drill out the remaining holes on the repair clip using a 1/4in drill bit.
5. Install the bolts in the remaining holes and tighten all locknuts (Fig A7).
