# TECH TALK

Volume 191, November, 2012

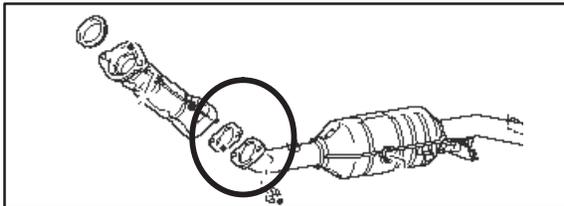
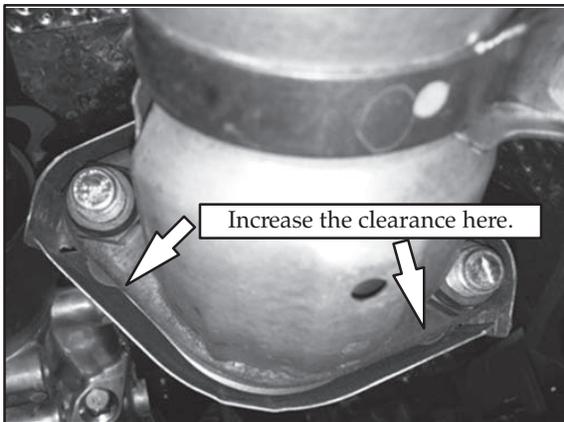
If the noise occurs around 2500 rpm, while driving or in Park, inspect the exhaust gasket between the front pipe and catalytic converter. It's possible that a front pipe heat shield is contacting the the exhaust gasket tabs. The noise can typically be recreated with the vehicle in Park for easy confirmation. To resolve this condition, increase the clearance between the heat shield and the tabs using a long screw driver or appropriate pry bar. Retest to confirm the repair.

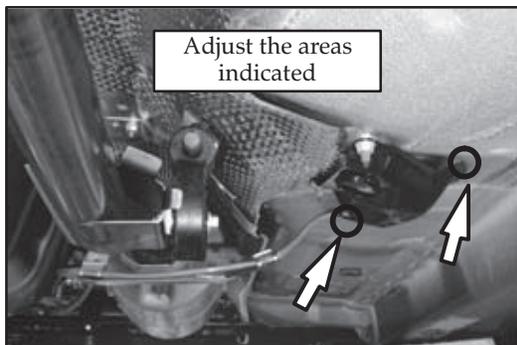
The second source of noise usually occurs around 3,000 rpm. The source may be insufficient clearance between the black metal shield protecting the rear O2 sensor wiring harness and the floorboard. Carefully apply downward pressure to adjust the clearance of the forward and outboard sections of the protector to 9-15 mm. Retest to confirm the repair. Take care that you don't damage the shield while adjusting the clearance.

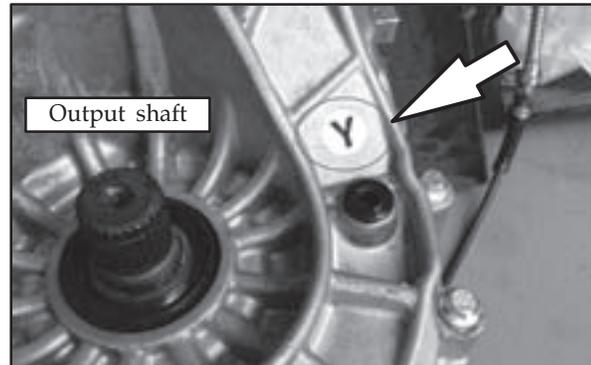
**TC-SST AXLE SEAL OIL LEAK** — 2008-13 Lancer Evolution, 2009-13 Lancer, Lancer Sportback with TC-SST. A production change has enlarged the left (driver's side) output shaft opening in the transmission case and a new, larger seal is used. When replacing the seal, first identify if you need a small (early) or large (late) seal. Look for a "Y" sticker on the case at the LH axle location.

CAPS lists both seal types and identifies the new, larger seal with "Y sticker" in the "Note" column. Transmissions with the sticker use the new seal (p/n 2509A007), and vehicles without the sticker use the original seal (p/n 2509A003). If you are replacing both sides, use the seal kit, (p/n 2509A015 "Y sticker," or p/n 2509A010 no sticker).

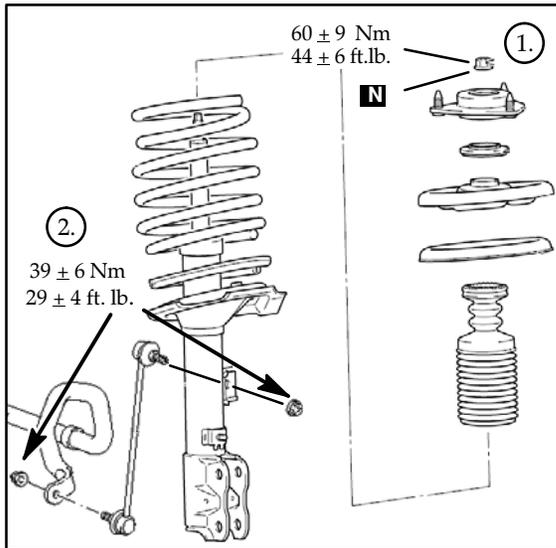
**FRONT SUSPENSION NOISE/KNOCK OVER BUMPS** — 2013 Outlander Sport/RVR. If a customer reports a noise from the front suspension when driving over bumps, it may be caused by either or both of the following conditions:

1. *Vehicles built before VIN DE005681, Sept. 24, 2012.* Make sure the nut securing the top of the strut shaft to the strut insulator is torqued to specification (see following illustration). If the strut shaft can move in the insulator it may cause the knock.
2. *Vehicles built before Sept. 21, 2012.* Insure the nuts securing the front stabilizer link to the stabilizer bar and the strut assembly are properly torqued (see following illustration). To torque the nut to spec, (39 ± 6 Nm, 29 ± 4 ft. lb) use a 5 mm hex wrench to hold the ball joint stud while torquing the nut using a 14mm crow's foot on your torque wrench. Refer to the "Tips from the Toolman" article

on page 6 for information on calculating the correct torque reading when using a crow's foot.

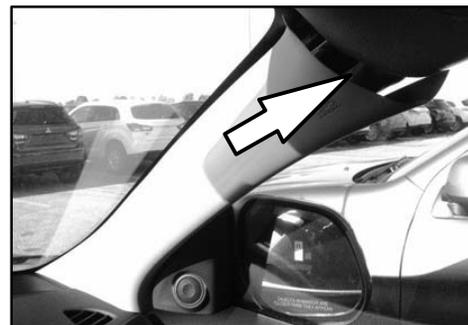
**A-PILLAR TRIM LOOSE** — 2013 Outlander Sport/RVR. If you see the top of the left or right A-pillar trim loose, inspect the retaining clips for misalignment or damage. Replace them as necessary using service manual procedures. Please submit a PQR if you see this condition on vehicles built after September 28, 2012.

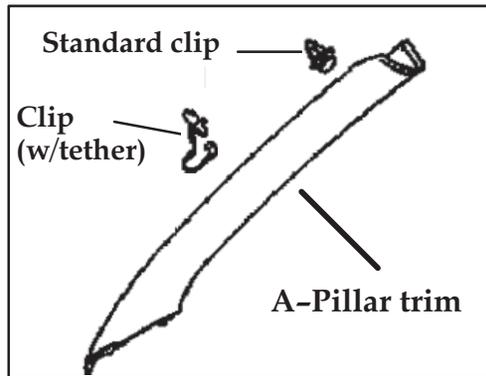
**IMPORTANT** - There are two different clip types used and they are location specific. The clip with the tether is positioned in the middle of

the trim. Use only the specified clip at this location. Refer to the following illustration for details.

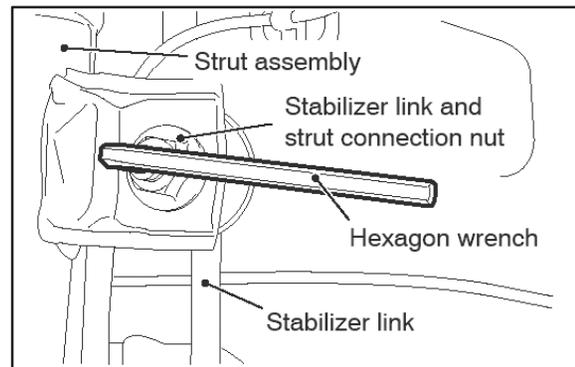
The stabilizer link pivot stud must be held with a hex wrench to prevent it turning during tightening (see illustration, right).

Because a socket cannot be used, a crow's foot is used with a torque wrench to torque the nut (not shown). However, if torqued to a reading of 29 ft. lbs, over-torquing occurs.

To properly torque the nut to the specified 29 ft lbs, the observed reading on the torque wrench must be 25 ft. lb. Results may vary depending on the length of your crow's foot and torque wrench.
