TECH TALK

Volume 192, December, 2012

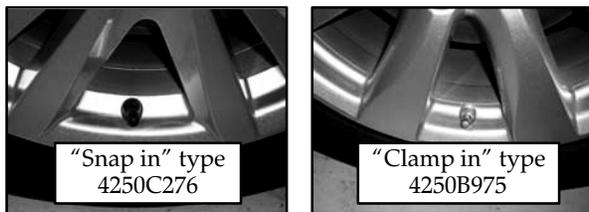
Due to a supply issue of the “snap-in” type Tire Pressure Monitoring System (TPMS) sensor, subject vehicles are temporarily being built using the 2012 clamp in type sensor. This change will affect approximately 6 weeks of production, or until the supply issue is resolved. An owner’s manual addendum card reflecting this change has been placed in the glove box of affected vehicles.

The TPMS sensor type can be easily identified by the valve stem.

This change will be reflected in future versions of ASA-CAPS. Until then, if a replacement sensor is required, please order the correct part as shown in the photos above. To insure appearance uniformity and owner’s manual consistency, use only the sensor type originally installed on the vehicle.

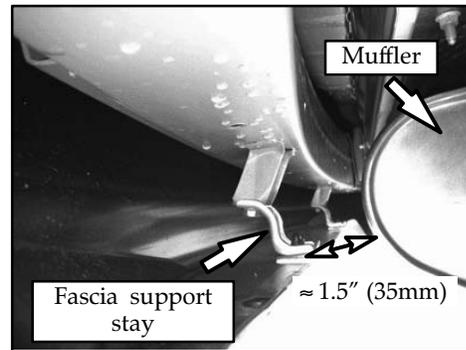
BUZZ OR RATTLE NOISE FROM REAR OF VEHICLE WHEN ACCELERATING — 2013 Outlander Sport/RVR. If a customer reports a buzz or rattle noise from the rear during acceleration, check the clearance of the rear fascia to the muffler. It should be approximately 1.5” (35mm) at the closest point. Some early production vehicles may have a deformed bumper support stay. If you find a deformed stay, determine if it can be restored to the correct position. If not, replace the stay.

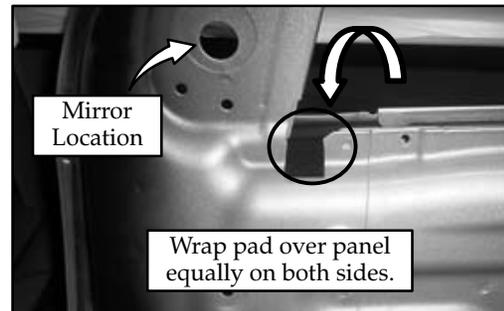
SQUEAK FROM FRONT DOOR WINDOW — 2013 Outlander Sport/RVR. Some early production vehicles may exhibit a squeak from either front door, as the window travels up or down. If this condition is noted, remove the inner door trim panel and check near the door mirror location for the presence and placement of a foam pad. The noise may be present if this pad is out of position, missing or not properly adhered. To address the condition cut a 25mm x 50mm piece of 10mm thick foam from the BSR kit (p/n# MB991752), remove the old pad, ensure the door surface is clean, then install the new pad in the original’s place. The photo (below) shows the correct position of the pad in a slight depression, wrapped over the top of the door panel equally on both sides.

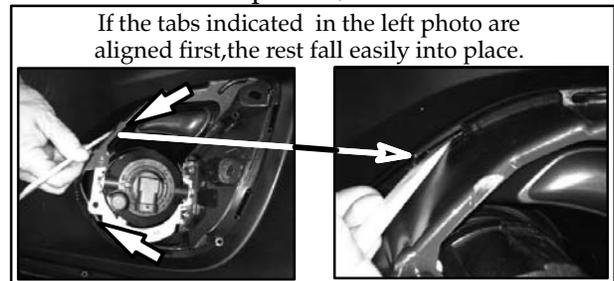
FOG LAMP BEZEL INSTALLATION — 2013 Outlander Sport/RVR. When reinstalling fog lamp bezels for Outlander Sport, particularly during accessory daytime running lamp installation, ensure all of the retaining clips for the bezel are properly seated. Use the following instructions to insure a proper fit and retention:

1. Insert and lock the 2 bezel locking tabs indicated in the photos, below.

2. Place a nylon trim stick between the bezel and the locking tabs (illustration below, left) while pressing the bezel into place. The tool will prevent the tension ribs from collapsing while inserting the locking tab into the bezel (illustration below, right).
