Technical Service Bulletin

| SUBJECT: HVAC MODE DOOR POP/CLICK NOISE | | No: TSB-12-55-006 | |
| | | MODEL: 2013 Outlander Sport/ RVR | |

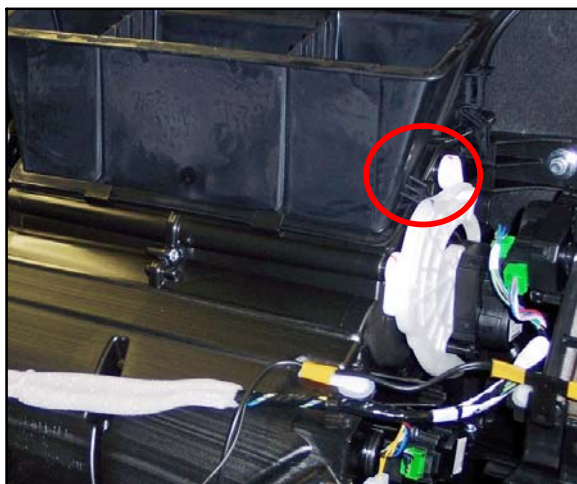
FOR REFERENCE

Correct clip position shown with HVAC assembly removed from the vehicle and mode door pivot cam removed.
