*** * TECHNICAL INFORMATION NOTICE * ***

DATE: October 22, 2012
TO: Mitsubishi Motors Parts Managers
Mitsubishi Motors Service Managers
RE: Outlander Sport TPMS Sensor - Temporary Production
TIN NO. TIN-12-42A-001

AFFECTED VEHICLES: Certain 2013 Outlander Sport

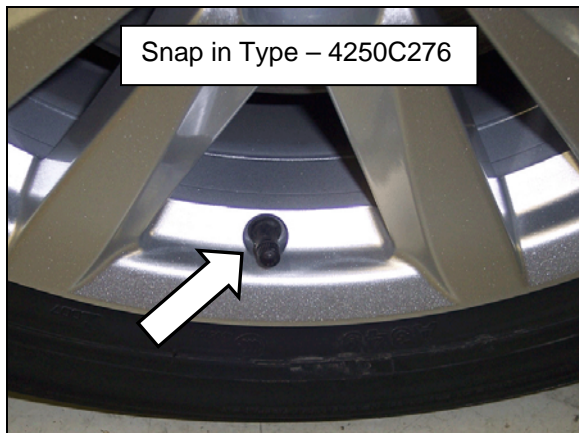
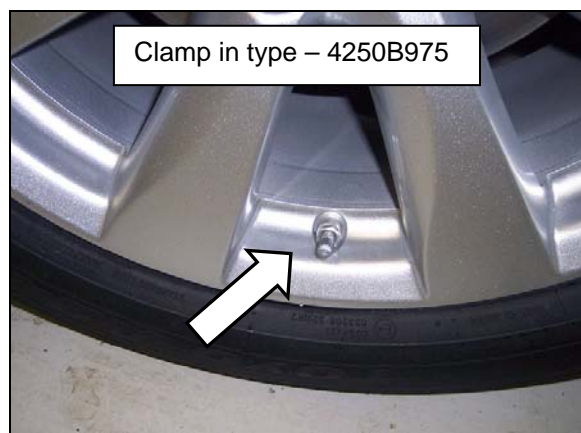
Due to a supply issue with the “snap-in” type Tire Pressure Monitoring System (TPMS) sensor, subject vehicles are temporarily being built using the 2012 “clamp in” type sensor. This change will affect approximately 6 weeks of production, or until the supply issue is resolved. An owner’s manual addendum card reflecting this change has been placed in the glove box of affected vehicles.

The TPMS sensor type can be easily identified by the valve stem.

This change will be reflected in future versions of ASA-CAPS. Until then, if a replacement sensor is required, please order the correct part number shown in the photos above. To insure appearance uniformity and owner’s manual consistency, use only the sensor type originally installed on the vehicle.
