Technical Service Bulletin

SUBJECT: NO "READY" MODE IN EXTREME COLD WEATHER			No: TSB-12-54-016
			DATE: December, 2012
			MODEL: 2012 i-MiEV
CIRCULATE TO:	<input type="checkbox"/> GENERAL MANAGER	<input checked="" type="checkbox"/> PARTS MANAGER	<input checked="" type="checkbox"/> TECHNICIAN
<input checked="" type="checkbox"/> SERVICE ADVISOR	<input checked="" type="checkbox"/> SERVICE MANAGER	<input checked="" type="checkbox"/> WARRANTY PROCESSOR	<input type="checkbox"/> SALES MANAGER

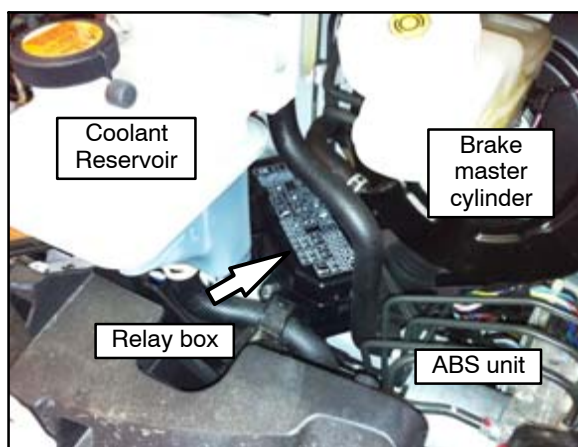
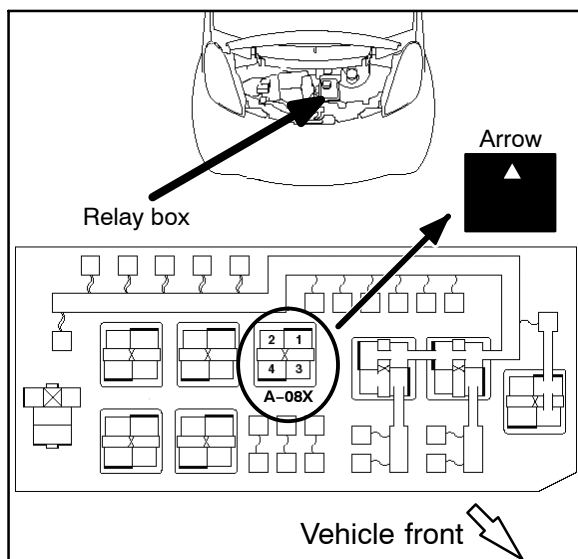
Owners of some affected vehicles may report they can not set the vehicle to "READY" mode in extreme cold weather (approximately -25°C , -13°F). This may be due to a frozen EV control relay. This TSB advises dealers that an improved EV control relay is available to correct this condition, and provides replacement instructions.

4. Disconnect the negative (—) 12V battery cable.
 5. Remove the relay box cover. The relay box is located under the hood below the brake master cylinder.

6. Replace the EV control relay (relay socket A-08X) with an improved part. Refer to the Parts Information section of this TSB for details.
- !! IMPORTANT !!** Take note of the arrow (Δ) on top of the relay. Install the new relay with the arrow pointing in the same direction.
