## SERVICE INFORMATION BULLETIN

**TITLE :** Cheater glass seal rework

**DOCUMENT # :** 11 A 028

**AFFECTED VEHICLES :** 12C

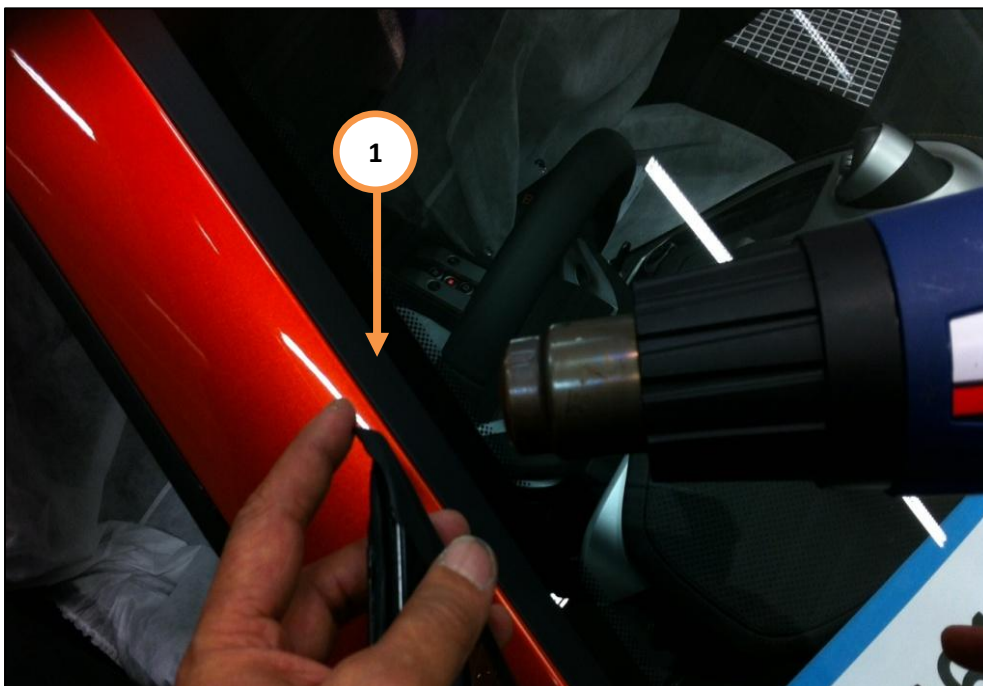
**SITUATION :** Quality Engineering at McLaren Automotive have identified an excessive gap between the cheater glass, the divider bar and the primary door seal. This will potentially result in water ingress into the cabin.

1. Once the new cheater glass seal (Part number 11A5300CP and/or 11A5301CP) has been fitted into the vehicle a heat gun must be used to complete the rework described below.
2. Set the heat gun to 170 degrees Celsius and open the affected door.
3. Position the heat gun approximately 150mm away from the tip of the cheater glass seal (1).

**Care Point:** Do not apply heat and mould the seal at the same time.

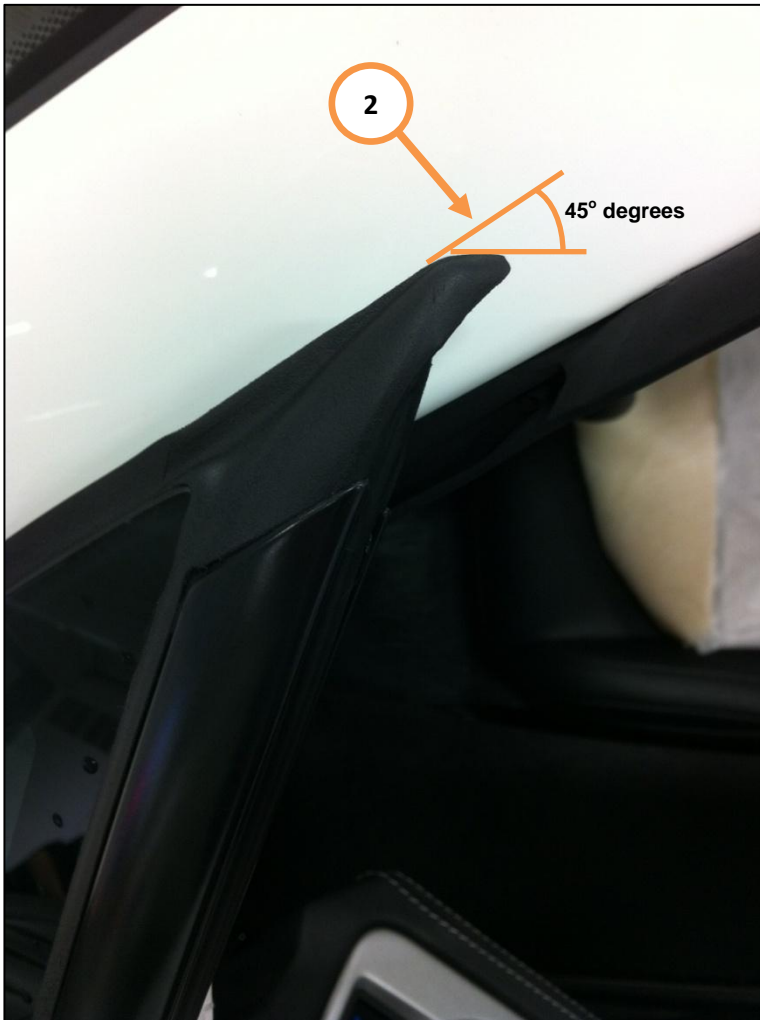
6. This condition creates a better contact between the cheater glass seal and the primary door seal when the door is closed, preventing water passing the seal and entering into the cabin.

4. Apply heat for 15-20 seconds until the cheater glass seal can be moulded by hand.
5. Once the seal can be manipulated move the tip of the seal inboard until the seal is moulded approximately 45 degrees (2).
