## SERVICE INFORMATION BULLETIN

**TITLE :** Turbocharger leakage under pressure test condition

**DOCUMENT # :** 11 F 010

**AFFECTED VEHICLES :** 12C Coupe and Spider

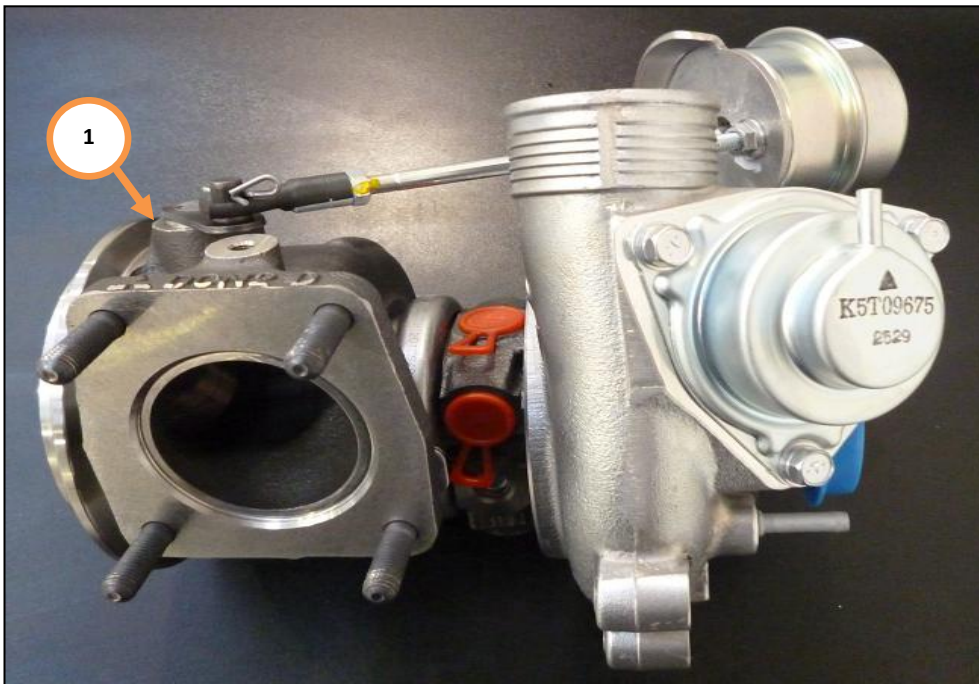
### CONDITION 1

Leakage will occur around the wastegate shaft where it exits the turbine housing (1). Due to the clearances required for the shaft to operate at extreme temperatures it is not possible to seal this area completely. This is a normal condition.

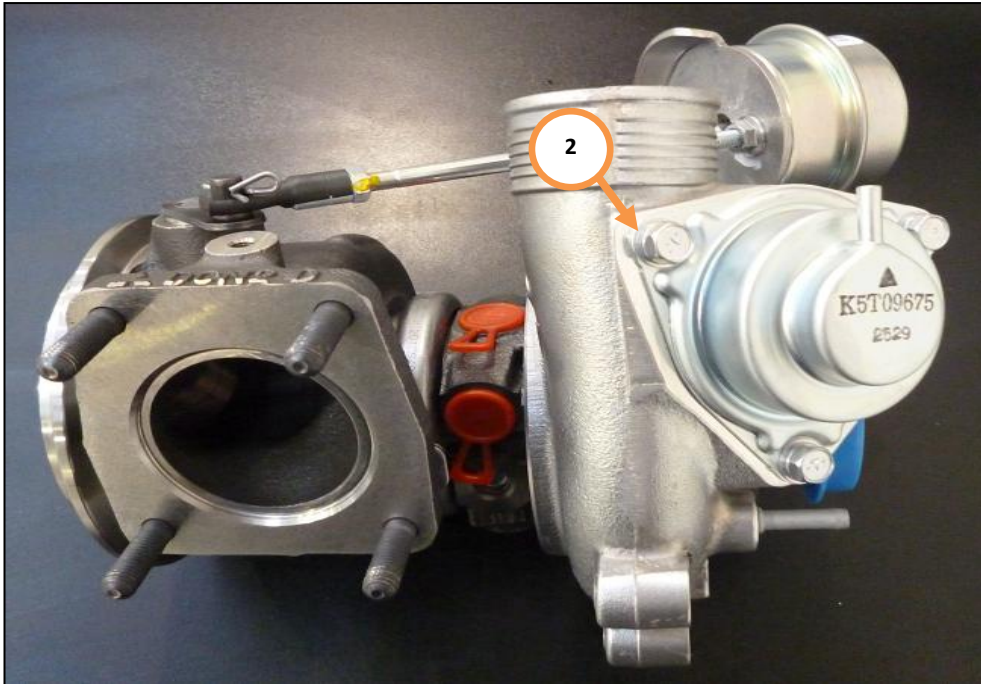
## CONDITION 2

Leakage will occur around the top bolt of the dump valve (2). This is a normal condition.

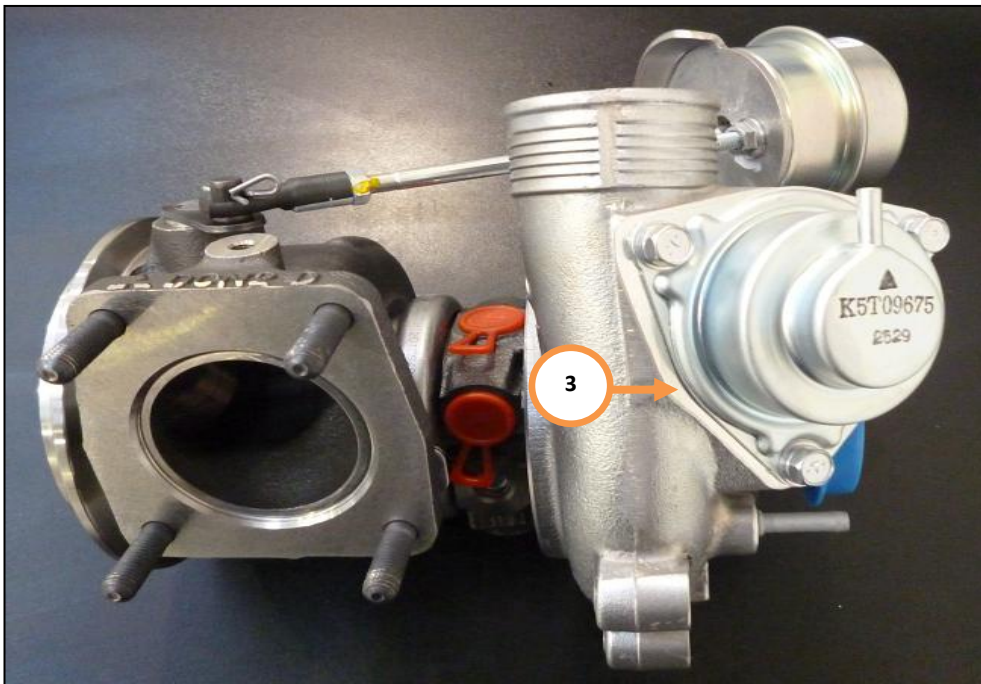
## CONDITION 3

Leakage will also occur at the dump valve capsule (3). If leak detection fluid is used, bubbles will appear under the capsule where it joins the turbocharger housing and at the top mounting bolt position. This is a normal condition.
