## SERVICE INFORMATION BULLETIN

**TITLE :** Deformation of headlining

**DOCUMENT # :** 11 N 010

**AFFECTED VEHICLES :** All MP4-12C's built up to 28<sup>th</sup> August 2012

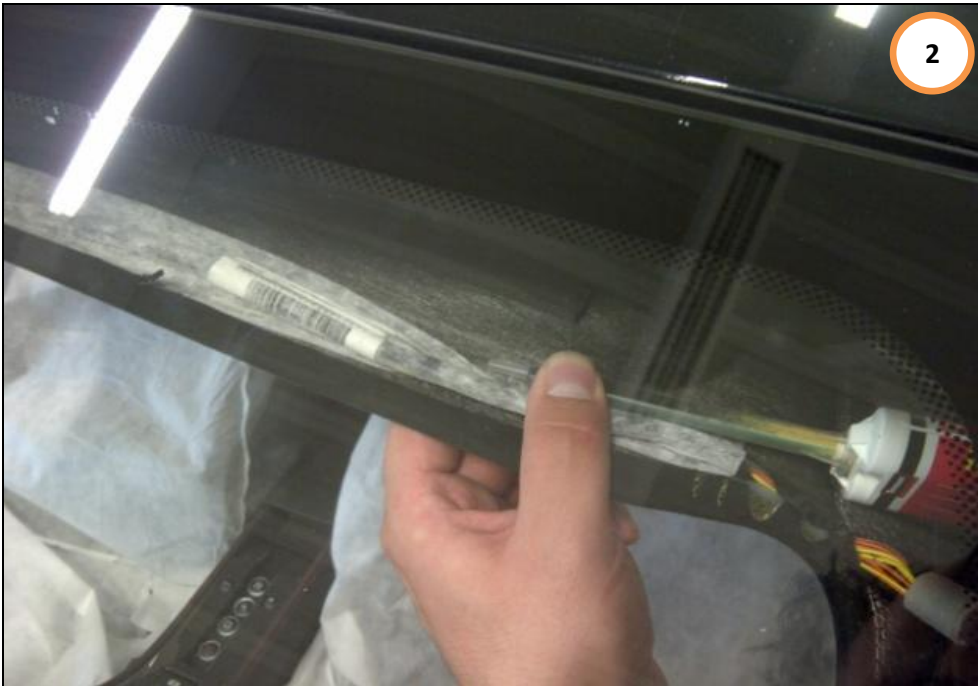
6. Inspect the left-hand side of the headlining for any visible lacerations. If present they must be filled using one of the recommended adhesive listed at the end of this document before proceeding to step 7.

**Care point:** Do not cover the Harness label with adhesive (3).
