SERVICE CAMPAIGN BULLETIN

CAMPAIGN REF: 01G

TITLE : Vehicle software update to platform 9.0. **UPDATED 22/06/2012**

DOCUMENT # : 11 M 039

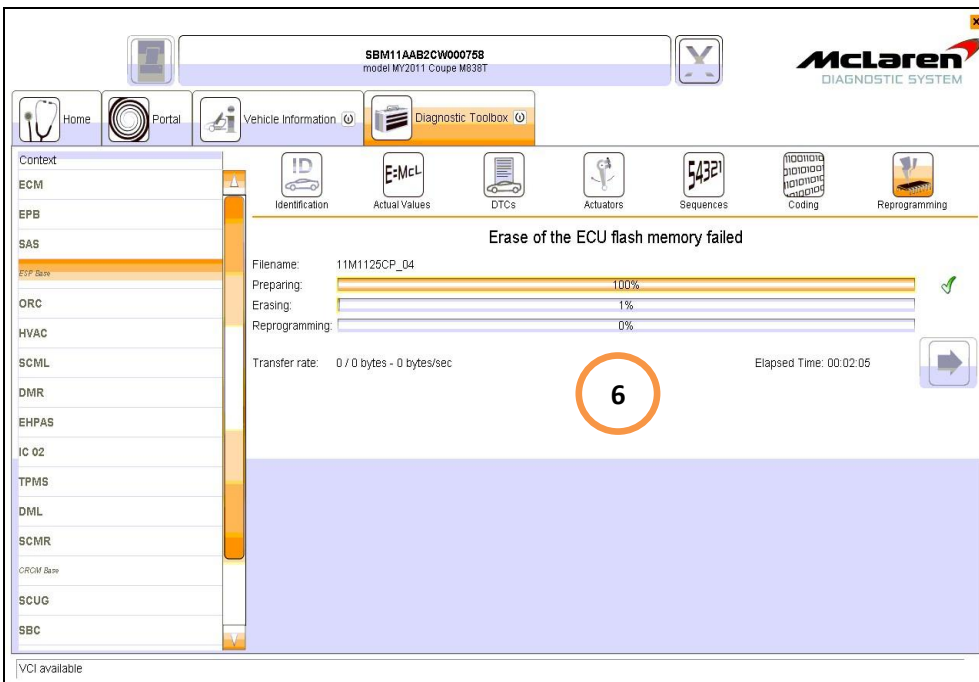
28. After the preparation phase of the download the system may inform the operator that the Erase of the ECU Flash Memory Failed". In this circumstance the ESP control unit will require a power cycle (6).

29. Proceed and reflash the ESP module, when the Elapsed Time is between 1.20 to 1.28 seconds (7), disconnect the ESP connector (9) wait for 5 seconds and then reconnect it. The “Preconditions failed” will now be displayed. Proceed to step 31.

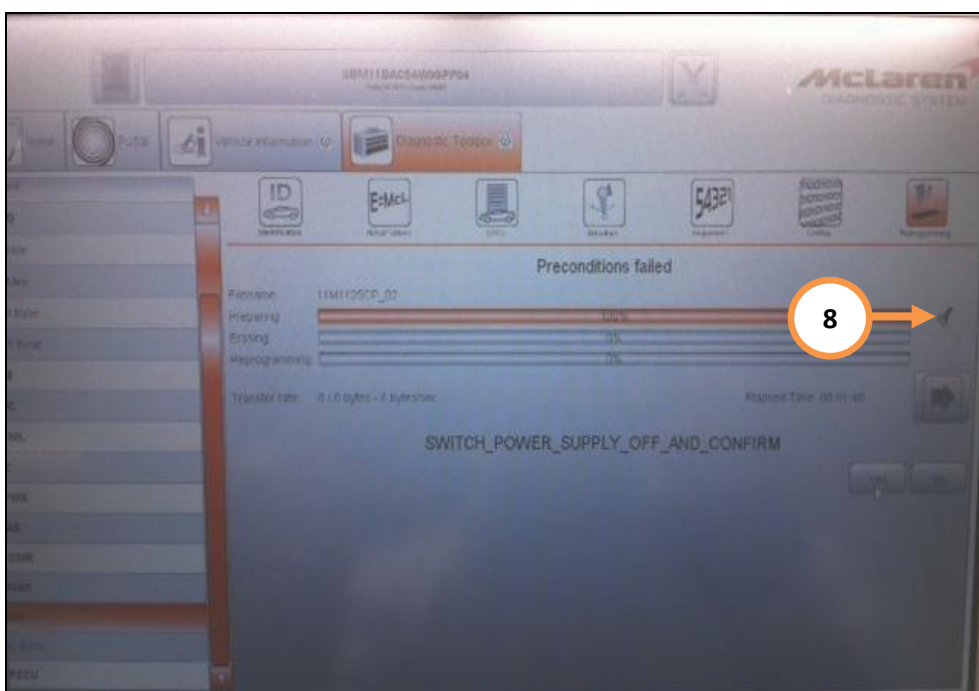
30. After the preparation phase of the download the system may inform the operator that the “Preconditions failed”. In this circumstance the ESP control unit will require a power cycle (8).

31. Disconnect the ESP connector (9) and wait for 5 seconds before reconnecting.

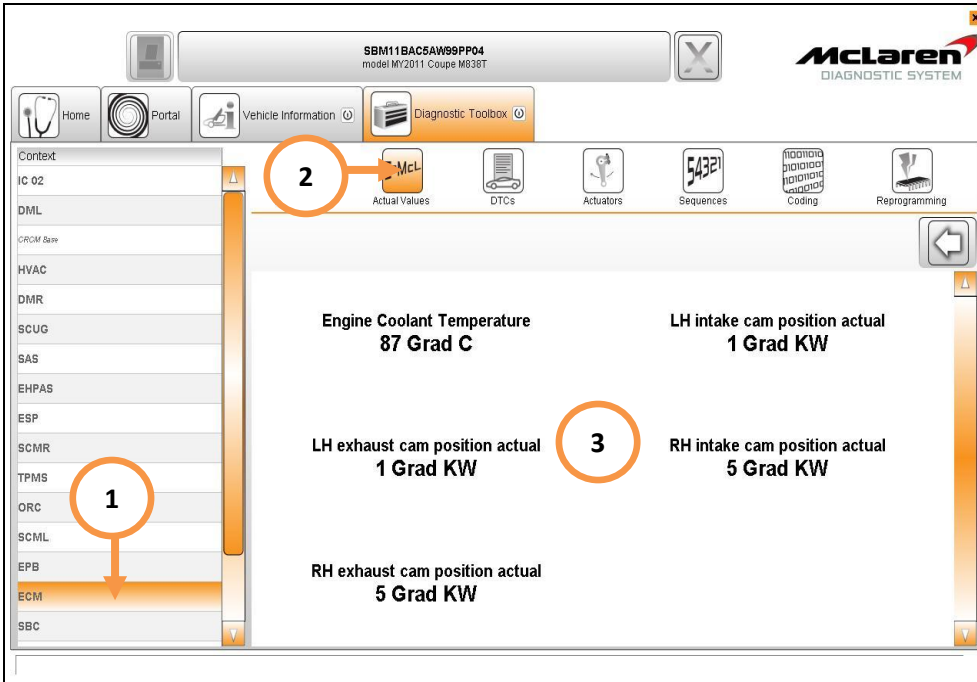
46. Select ECM (1), then Actual Values (2), select the following values as per the screenshot below (3), select the play button to access the required data screen.
47. The Inlet and exhaust camshaft values should be between 1 and 4, both values will fluctuate slightly. If all values are correct no further action is required. If any values are incorrect proceed to step 48 to carry out the camshaft adaption.

48. Switch the engine off, wait 30 seconds, restart the engine and recheck the values. Repeat this procedure until the target values are obtained.
49. Insert the Owner Manual Supplement (1) into the vehicles book set
