## SERVICE CAMPAIGN BULLETIN

**CAMPAIGN REF:** 01D  
**TITLE :** Retrofit noise insulation to the cooling fan relays  
**DOCUMENT # :** 11 E 001

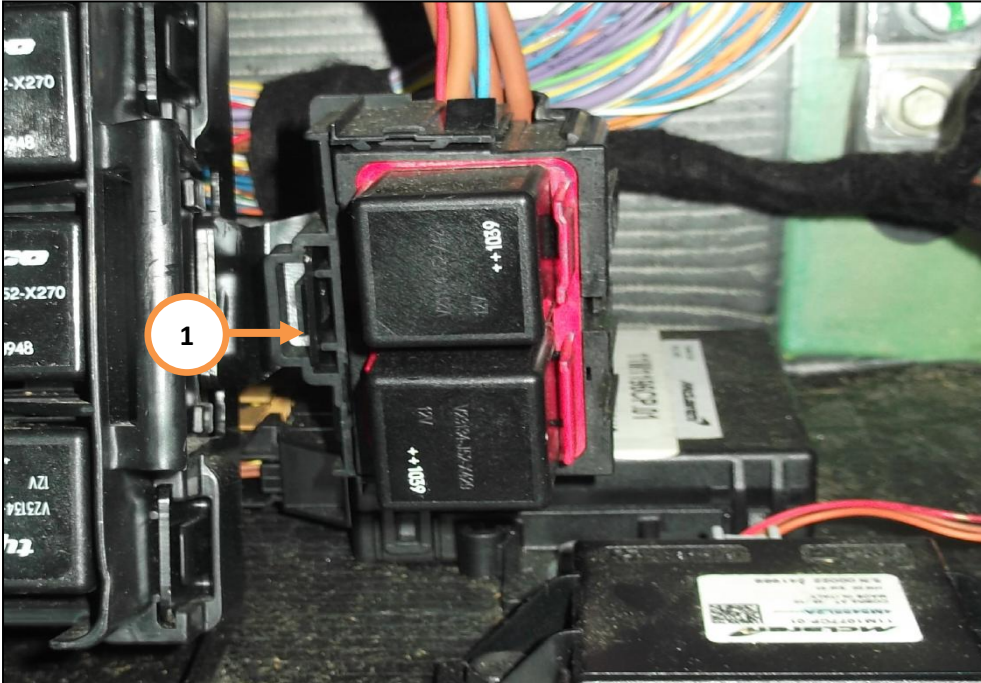
**SITUATION :** Quality Engineering at McLaren Automotive have identified that the noise produced by the cooling fan relays when switching is excessive.

6. Detach the cooling fan relay base from its mounting position (1).
7. Secure the insulation to the relay as illustrated on the following pages.
