## SERVICE CAMPAIGN BULLETIN

**CAMPAIGN REF:** 013

**TITLE :** Replace vehicle keys where previous non response faults have been reported but keys have not been replaced

**DOCUMENT # :** 11 M 035

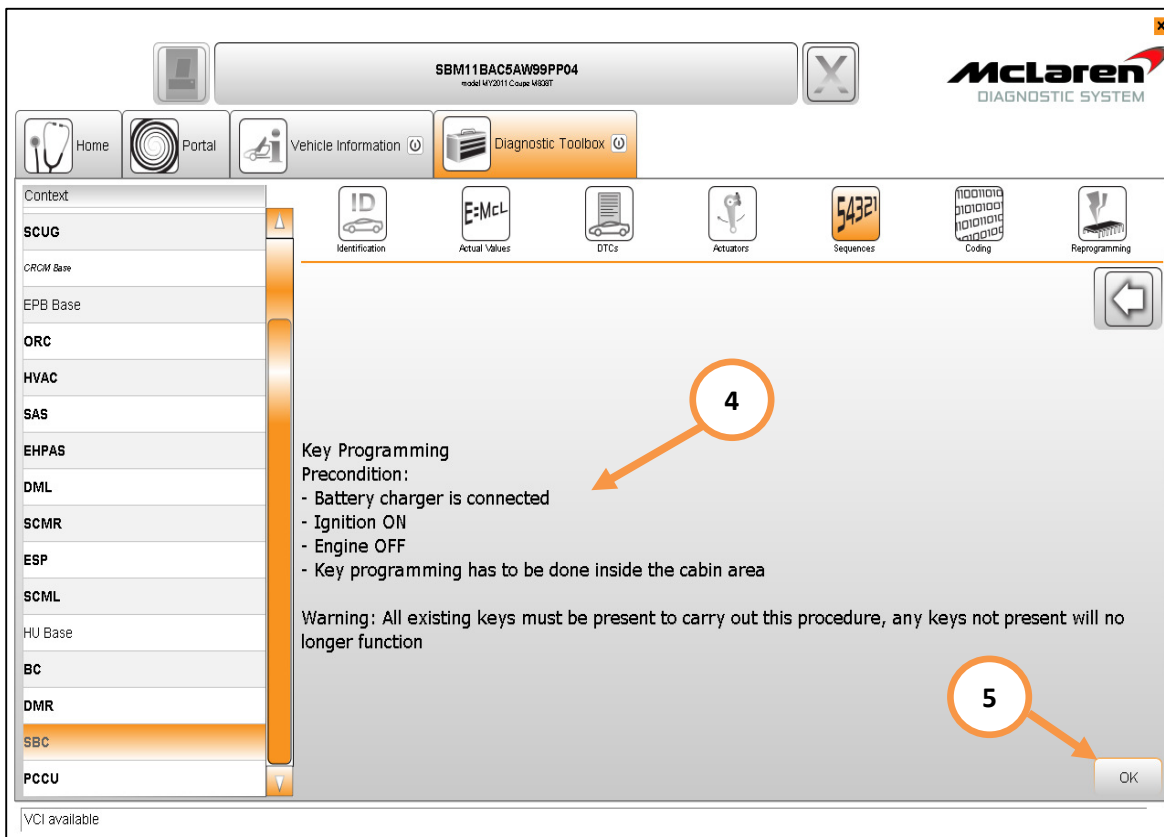
**SITUATION :** Quality Engineering at McLaren Automotive have identified that keys reporting a non-response issue, that have subsequently been recovered by removing and installing the battery have a potential risk of future hardware failure.

3. Ensure that the list of preconditions displayed are met (4), click the ok button to proceed (5) and follow the on screen instructions to programme the new keys.
