TECH TIP

“Exhaust Gas Temp” (DPR Outlet) Reading Error

All 2011-2013 Model Year - NE8J, NJ8J, and NV8J Models.

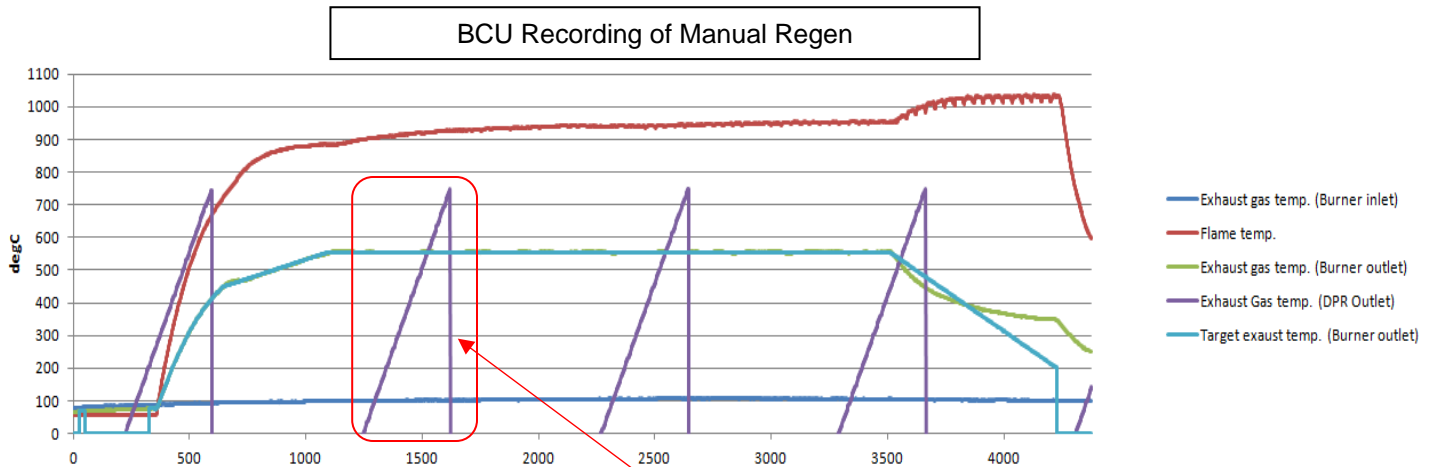
Interpretation error with the BCU reading of “Exhaust Gas Temp” (DPR Outlet).

The latest version of ECU control software (“Soot Control”, December 2012) has an interpretation error with the BCU reading of “Exhaust Gas Temp” (DPR Outlet). The interpretation error is with the analog to digital conversion for DPR Outlet Temperature as it is broadcast over the CAN to the BCU for recoding purposes only. The DPR Outlet Temperature read by the ECU (as seen on the DX Reports etc.) is an analog signal and remains correct. Only the analog to digital conversion of this temperature broadcast back to the BCU for reference only is incorrect. This condition will be the same for all ECU’s programmed with the December 2012 “Soot Control” control software. This condition should be ignored.
