## Service Campaign 62-01

**AFFECTED:** Certain 2013 Winnebago Adventurer, Journey, Tour and Itasca Suncruiser, Meridian and Ellipse model motor homes.

**DATE:** August 17, 2012

**SUBJECT:** Roof A/C Mounting Verification

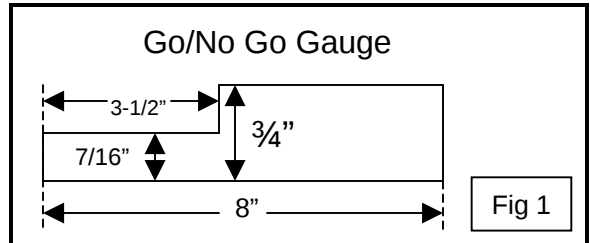
1. Construct wood gauge to specifications in (fig 1).

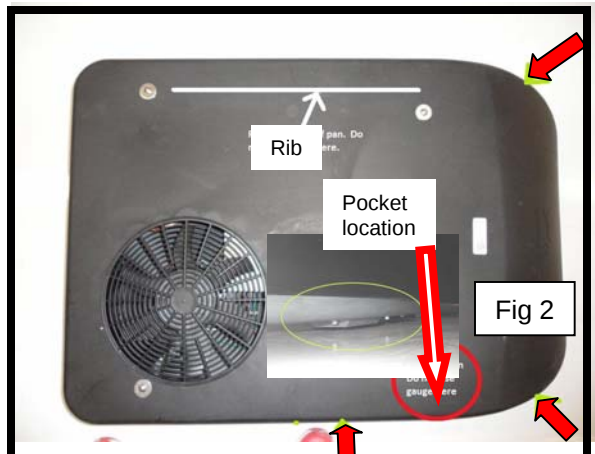
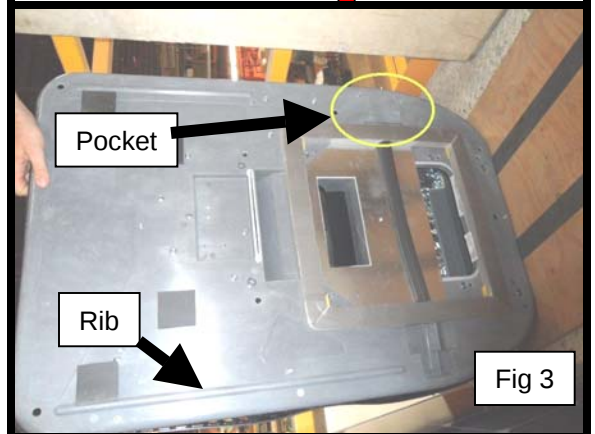
2. Use gauge (fig 1) at front right, front left corners and the middle of the right side areas indicated by arrows (fig 2).

**Note:** Make sure gauge does not interfere with rib on bottom of pan on left side or pocket on right side. Also pocket should not contact roof (fig 3).

The 7/16" gauge should slide under the pan in all three test points and the 3/4" gauge should not.

If gap test passes no further action required.

If gap test fails, refer to **Roof AC Mounting Repair Process**.

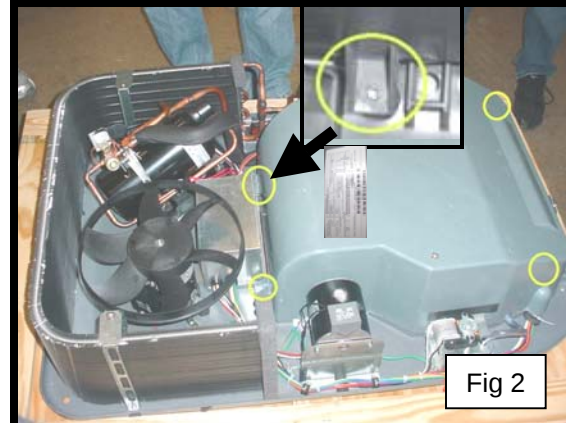
2. Remove inner cover. Inspect attachment tabs for cracks (fig 2). If cracked, a washer should be added when cover is reinstalled. If tab has broken off a new cover will be needed. Order cover p/n 183061-01-700.

**Note:** If cover is replaced, record model and serial number on new cover from original cover label.
