SERVICE BULLETIN

Classification: EC12-04	Reference: NTB12-087	Date: October 3, 2012
----------------------------	-------------------------	--------------------------

2009-2010 FRONTIER, XTERRA, AND PATHFINDER; CRUISE CONTROL INTERMITTENTLY TURNS OFF

APPLIED VEHICLES: 2009 – 2010 Frontier (D40)
2009 – 2010 Xterra (N50)
2009 – 2010 Pathfinder (R51)

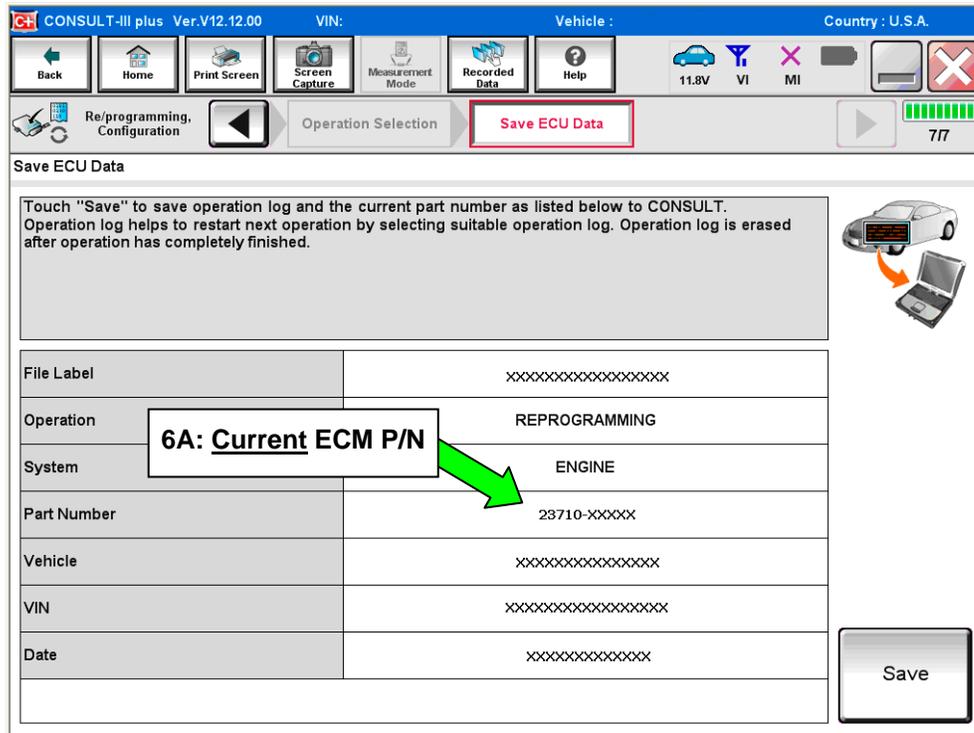
Figure 2

6. When you get to the screen shown in Figure 2, confirm this bulletin applies as follows.

A. Find the ECM **Part Number** and write it on the repair order.

NOTE: This is the current ECM Part Number (P/N).

B. Compare the P/N you wrote down to the numbers in the **Current ECM Part Number** column in **Table A** on page 5.

- If there is a match, this bulletin applies. Continue with the reprogramming procedure.
- If there is not a match, this bulletin does not apply. Close C-III plus and refer to ASIST for further diagnostic information.

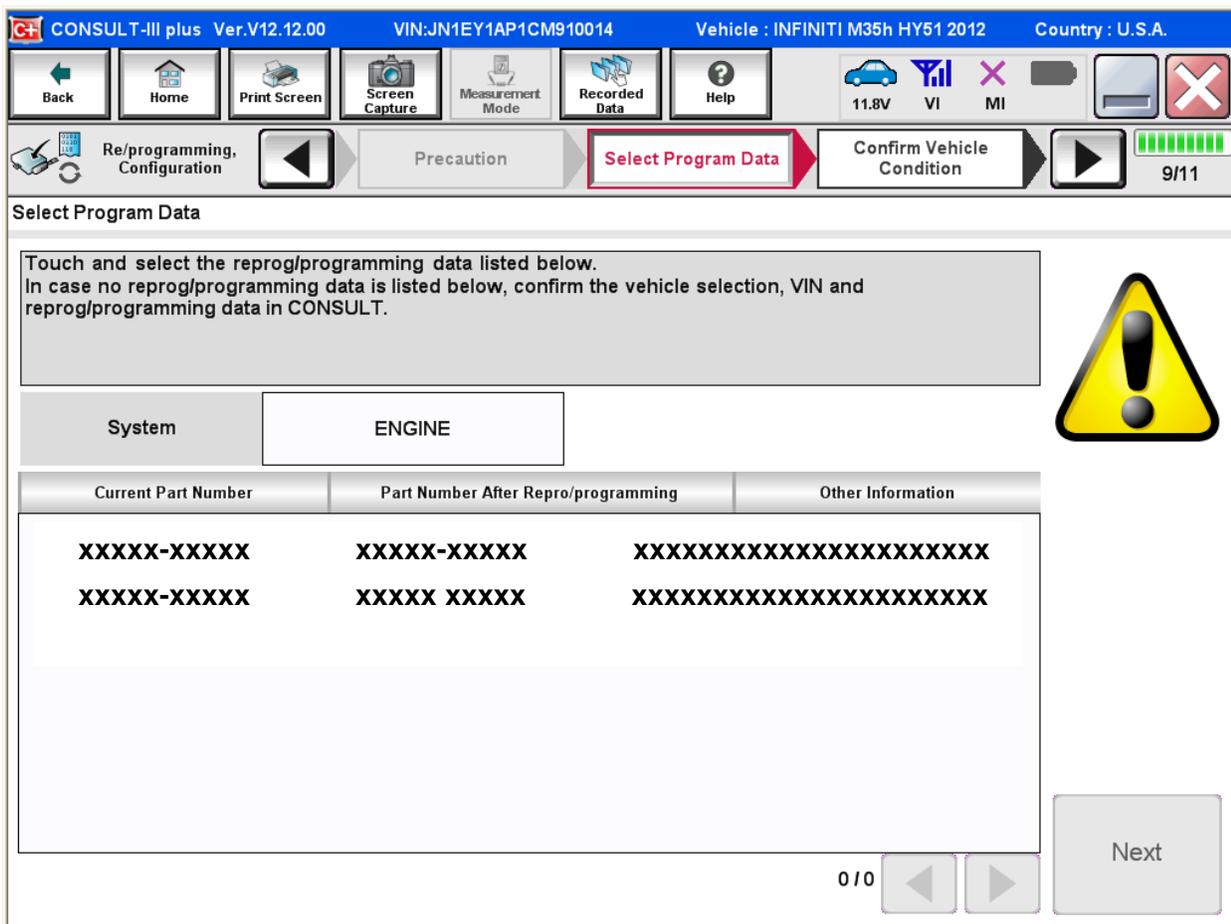
- In some cases, more than one new P/N for reprogramming is available.
 - In this case, the screen in Figure 3 displays.
- Select and use the reprogramming option that **does not** have the message “Caution! Use ONLY with NTBXX-XXX”.
- If you get this screen and it is blank (no reprogramming listed), it means there is no reprogramming available for this vehicle. Close C-III plus and refer back to ASIST for further diagnosis.

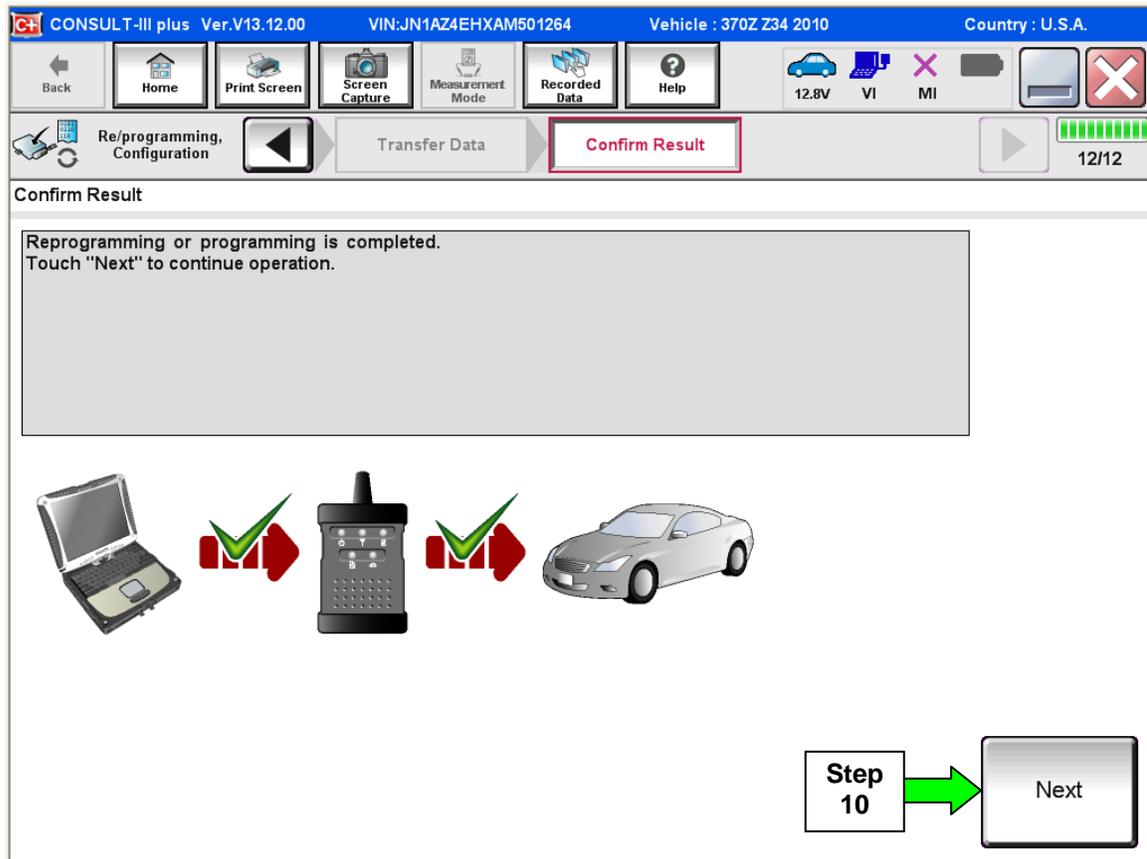
8. When the screen in Figure 4 displays, reprogramming is complete.
9. Disconnect the battery charger from the vehicle.
10. Select **Next**.

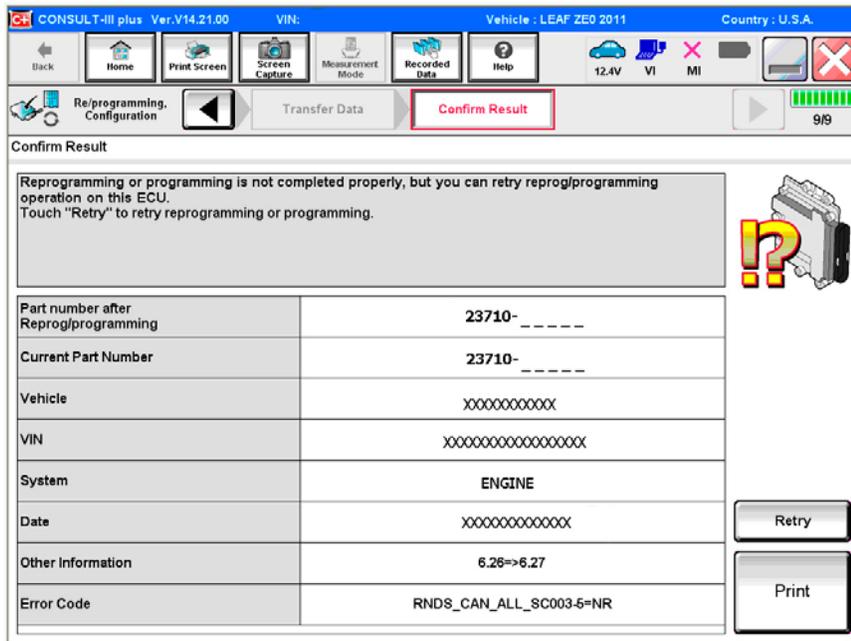
CAUTION: If reprogramming does not complete and the **!?** displays as shown in Figure 5 on page 8:

- Check battery voltage (12.0 – 15.5V).
- Ignition is ON, engine is OFF.
- External Bluetooth® devices are OFF
- All electrical loads are OFF.
- **Select retry and follow the on screen instructions.**
- Retry may not go through on first attempt and can be selected more than once.

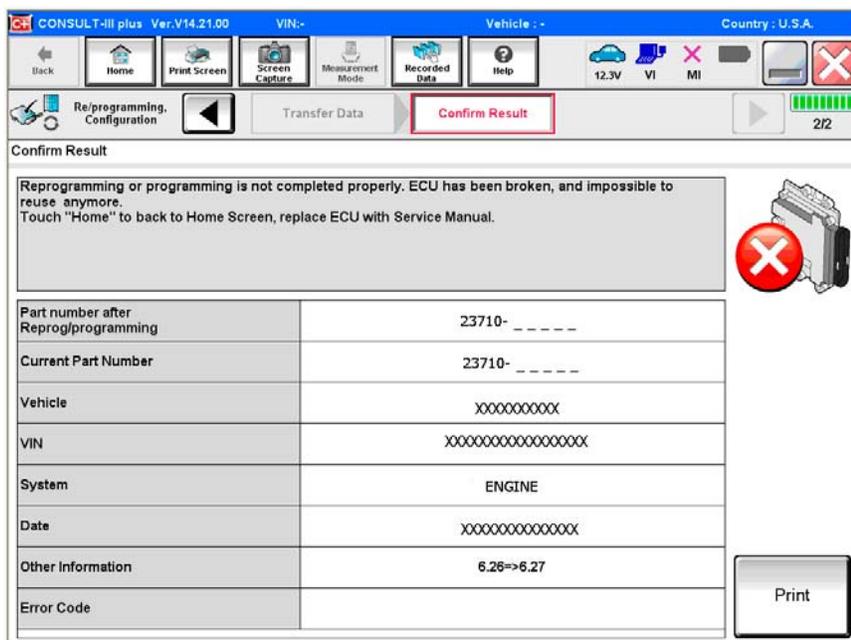
Figure 6

OR: If reprogramming does not complete and the **X** displays as shown in Figure 6:

Do not disconnect VI or shut down Consult III plus if reprogramming does not complete.

- Check battery voltage (12.0 – 15.5V).
- CONSULT A/C adapter is plugged in.
- Ignition is ON, engine is OFF.
- Transmission in Park
- All C-III plus / VI cables are securely connected.
- All C-III plus updates are installed.
- **Select Home, and restart the reprogram procedure from the beginning.**

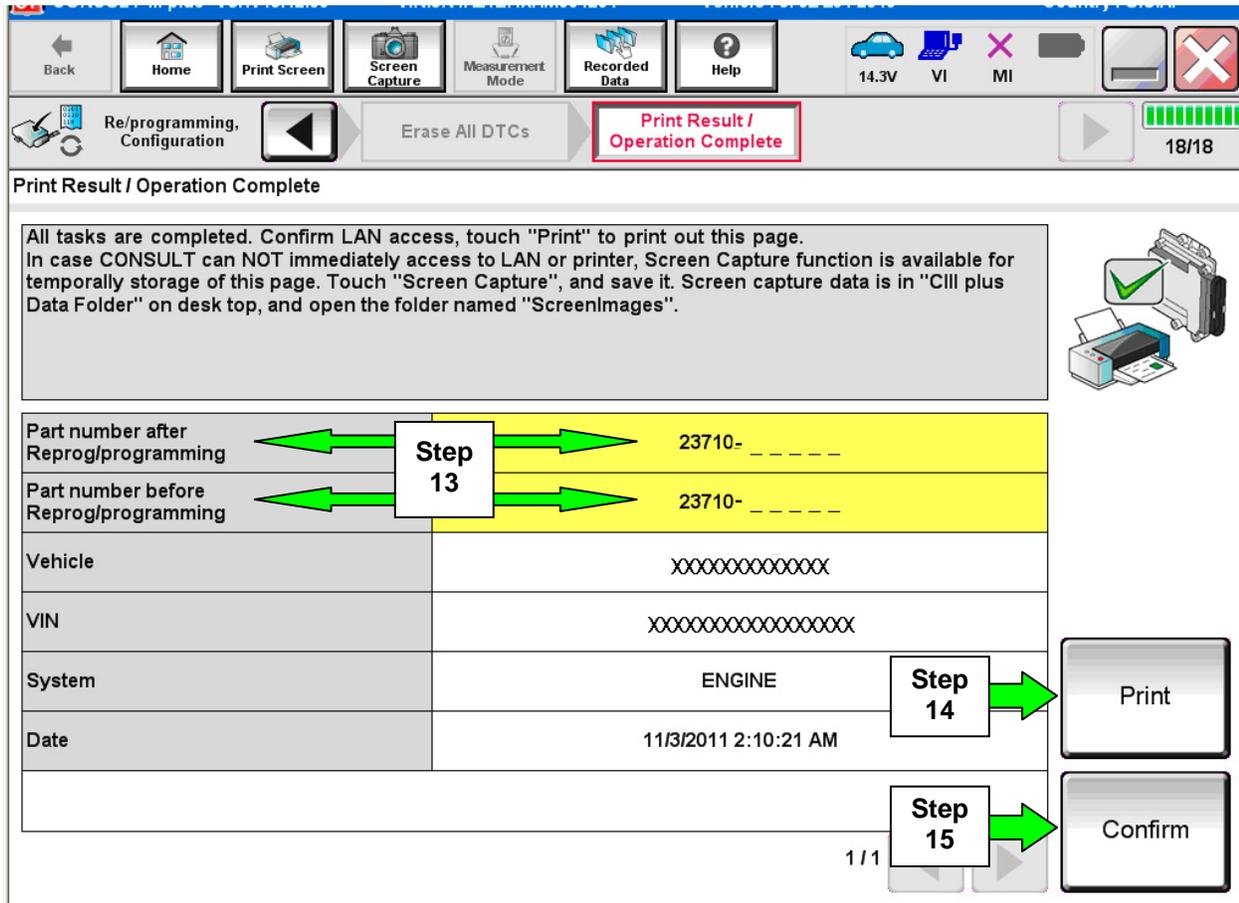
12. When the entire reprogramming process is complete, the screen in Figure 7 will display.

13. Verify the before and after part numbers are different.

14. Print a copy of this screen (Figure 7) and attach it to the repair order for warranty documentation.
