ITB12-067

October 25, 2012

## **VOLUNTARY SERVICE CAMPAIGN 2013 JX35 ECM REPROGRAM FOR AIR FUEL SENSOR**

**CAMPAIGN ID #:** PC185**APPLIED VEHICLES:** 2013 JX35 (L50)**Check Service Comm to confirm campaign eligibility**

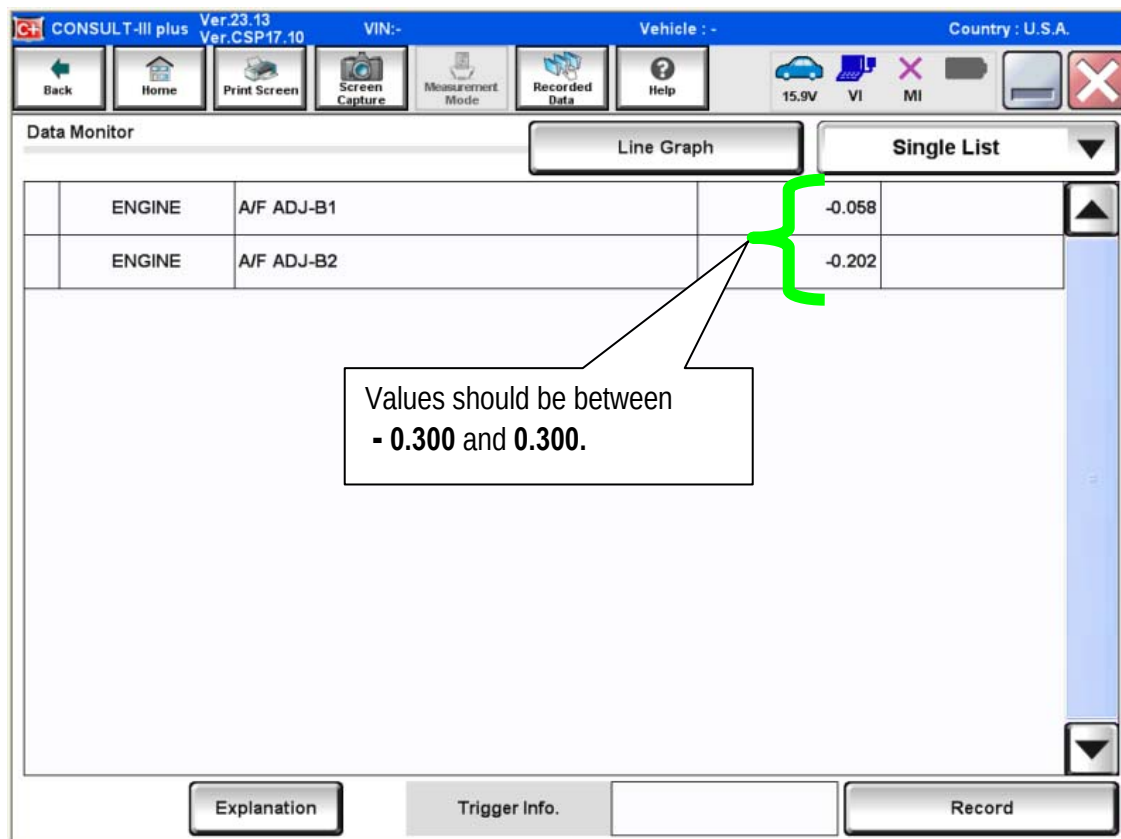
Figure A5

10. Check values for **A/F ADJ-B1** and **A/F ADJ-B2**.

- Value for each sensor should be between – **0.300** and **0.300**.
- If a sensor (one or both) is out of the above specified range, make a note of it.
- Sensor(s) that are out of the specified value will be replaced later in this procedure.

**DO NOT** replace A/F sensors at this time.

If needed, replace A/F sensors after ECM reprogramming.

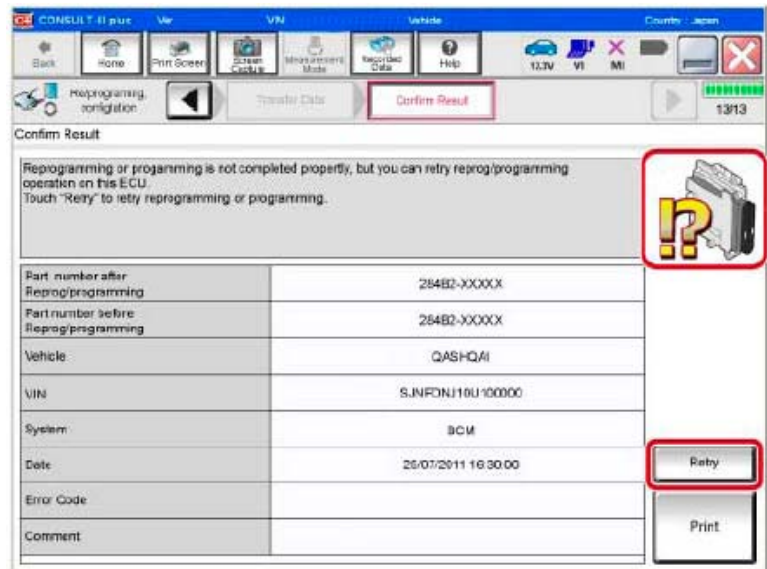
Figure 7

If reprogramming does not complete and the “!” icon displays as shown in Figure 7:

- Check battery voltage (12.0–15.5 V)
- Ignition is ON, engine OFF
- External Bluetooth® devices are OFF
- All electrical loads are OFF
- **Select retry and follow the on screen instructions**
- “Retry” may not go through on first attempt and can be selected more than once

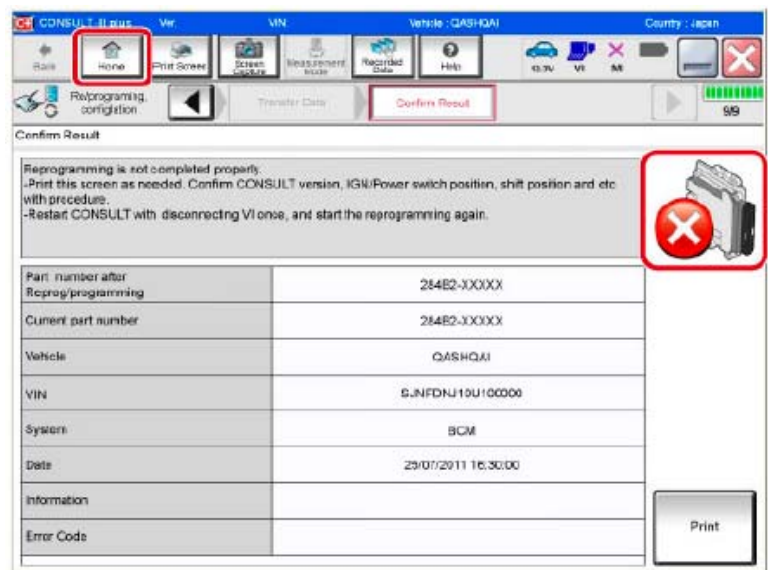
Figure 8

If reprogramming does not complete and the “X” icon displays as shown in Figure 8:

- Check battery voltage (12.0 – 15.5 V)
- CONSULT A/C adapter is plugged in
- Ignition is ON, engine OFF
- Transmission is in Park
- All C-III plus / VI cables are securely connected
- All C-III plus updates are installed
- **Select Home, and restart the reprogram procedure from the beginning**
