SERVICE BULLETIN

EC12-029

November 9, 2012

2013 GT-R; LACK OF POWER AND SPARK KNOCK WITH 91 OCTANE FUEL

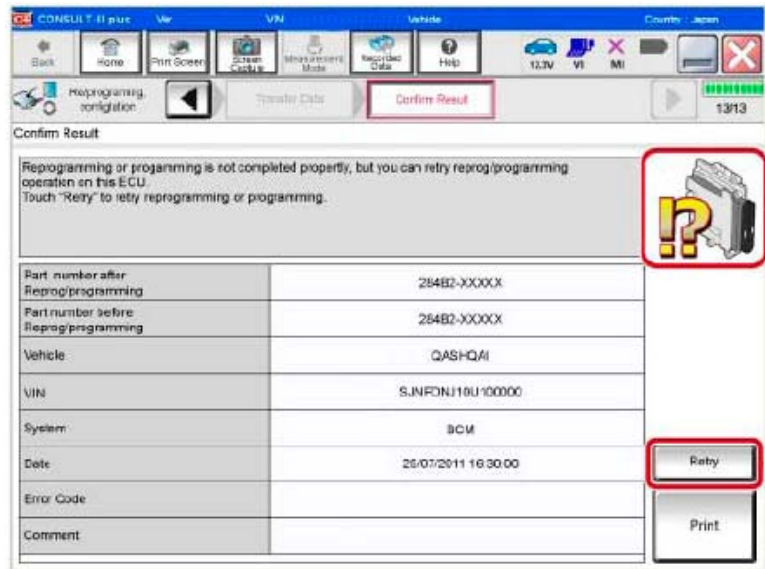
Figure 5

If reprogramming does not complete and the “!?” icon displays as shown in Figure 5:

- Check battery voltage (12.0–15.5 V)
- Ignition is ON, engine OFF
- External Bluetooth® devices are OFF
- All electrical loads are OFF
- **Select retry and follow the on screen instructions.**
- “Retry” may not go through on first attempt and can be selected more than once.

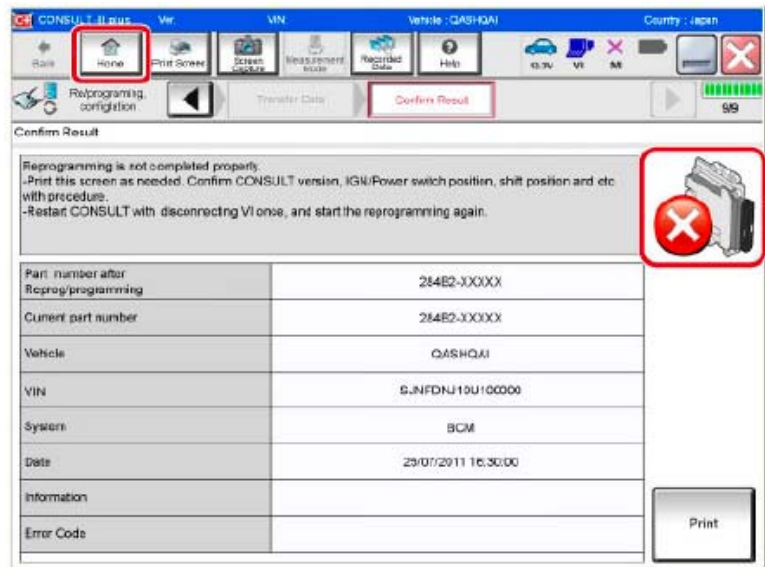
Figure 6

If reprogramming does not complete and the “X” icon displays as shown in Figure 6:

- Check battery voltage (12.0 – 15.5 V)
- CONSULT A/C adapter is plugged in
- Ignition is ON, engine OFF
- Transmission is in Park
- All C-III plus / VI cables are securely connected
- All C-III plus updates are installed
- **Select Home, and restart the reprogram procedure from the beginning.**
