SERVICE BULLETIN

Classification: EC12-031	Reference: NTB12-108	Date: November 28, 2012
-----------------------------	-------------------------	----------------------------

2013 VERSA SEDAN WITH A/T; DELAYED THROTTLE RESPONSE AT ENGINE START

APPLIED VEHICLES: 2013 Versa Sedan (N17) – with 4-speed A/T ONLY

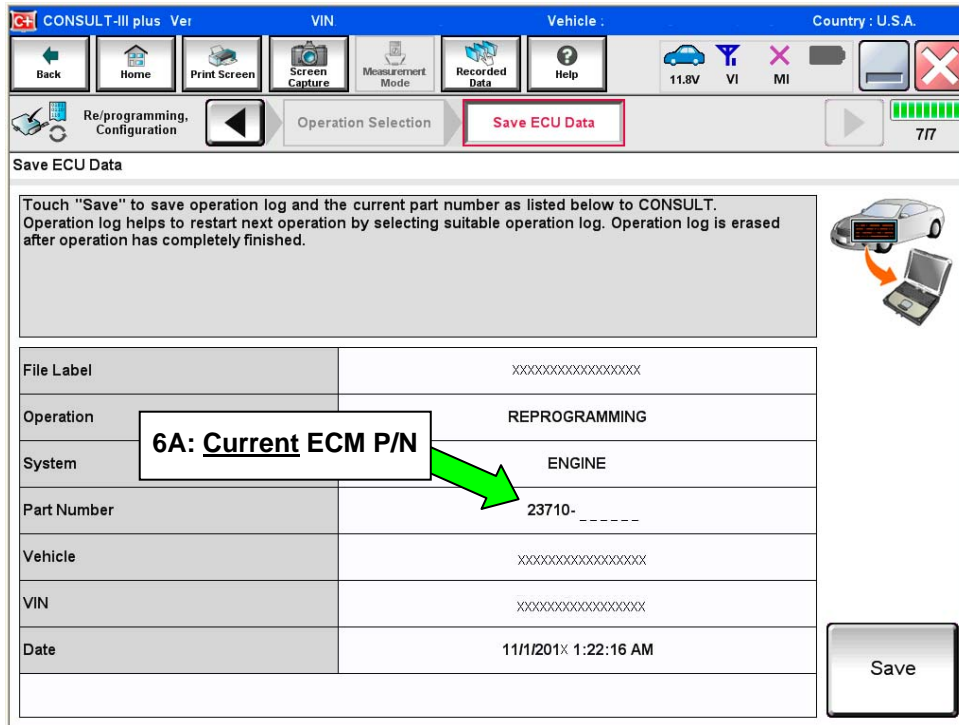
Figure 2

6. When you get to the screen shown in Figure 2, confirm this bulletin applies as follows.
- A. Find the ECM **Part Number** and write it on the repair order.

NOTE: This is the current ECM Part Number (P/N).

- B. Compare the P/N you wrote down to the numbers in the **Current ECM Part Number** column in **Table A**, below.

- If there is a match, this bulletin applies. Continue with the reprogramming procedure.
- If there is not a match, this bulletin does not apply. Close C-III plus and refer to ASIST for further diagnostic information.

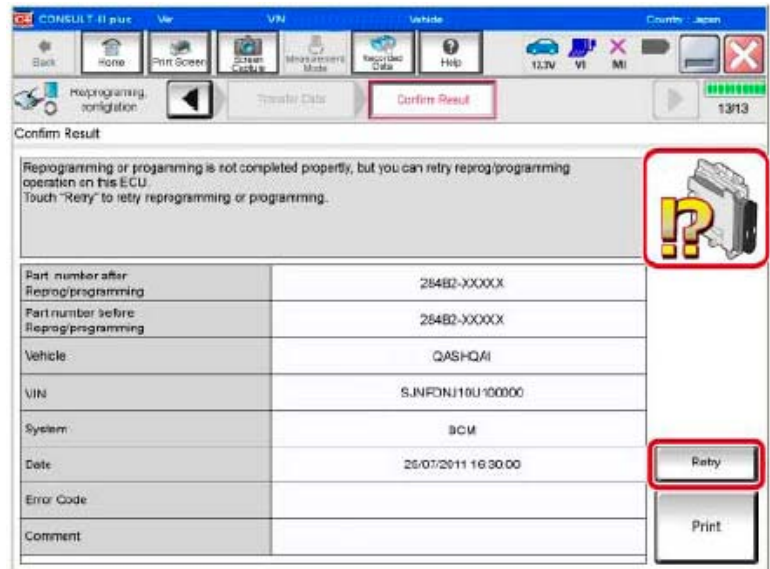
Figure 5

If reprogramming does not complete and the “!?” icon displays as shown in Figure 5:

- Check battery voltage (12.0–15.5 V).
- Ignition is ON, engine OFF.
- External Bluetooth® devices are OFF.
- All electrical loads are OFF.
- **Select retry and follow the on screen instructions.**
- “Retry” may not go through on first attempt and can be selected more than once.

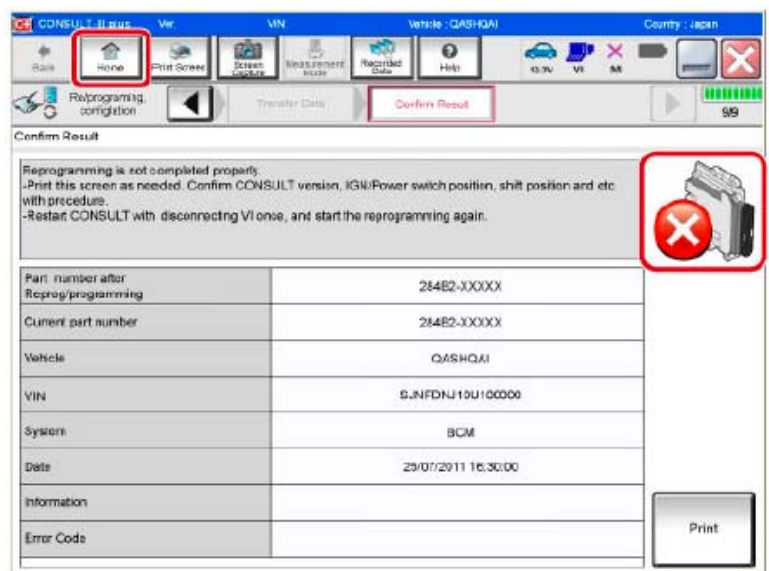
Figure 6

If reprogramming does not complete and the “X” icon displays as shown in Figure 6:

- Check battery voltage (12.0 – 15.5 V).
- CONSULT A/C adapter is plugged in.
- Ignition is ON, engine OFF.
- Transmission is in Park.
- All C-III plus / VI cables are securely connected.
- All C-III plus updates are installed.
- **Select Home, and restart the reprogram procedure from the beginning.**
