TECHNICAL BULLETIN

LTB00490NAS1

'Hood Open' Message Displayed with Hood Closed

Range Rover (LM)

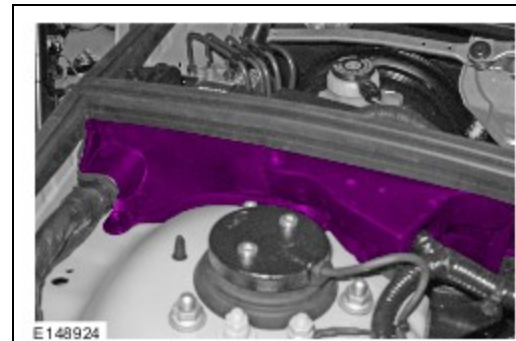
E148924

△ **NOTE:** The next step involves checking the bulkhead panel position to which the hood switch and bracket are mounted. Incorrect positioning will affect the operation of the hood switch.

8. Adjust the bulkhead panel:

- Loosen the 2 fixings to give approximately 3 mm of clearance between the base of the nut and bulkhead panel.
- Carefully pull the bulkhead panel towards the front of the vehicle as far as the fixings will allow (note that the bulkhead panel may crack if excessive effort is applied).
- Hold the panel firmly in position while the fixings are re-torqued.
- Following the adjustment of the bulkhead panel, re-check the operation of the hood switch to ensure correct functionality.
