TECHNICAL BULLETIN

J028NAS1
20-Dec-12

Safety Recall: Fuel Starvation

XF (X250)

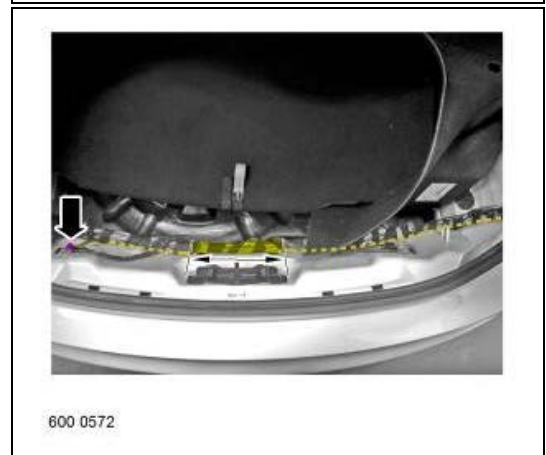
9. **⚠ CAUTION: Make sure that the ground cable is fully secured in the area of the luggage compartment lid latch, so that the ground cable cannot come in to contact with the latch. Failure to follow this instruction may result in damage to the vehicle.**

Using suitable tape, secure the ground cable to the underside of the existing harness at suitable points along the rear panel of the luggage compartment.

- Fully secure the ground cable to the existing harness in the area directly below the luggage compartment lid latch.
