# Service Bulletin

Subject: **Re-mapping ECU and Cush Drive Update**

Product: **F3 675 - F3 ORO**

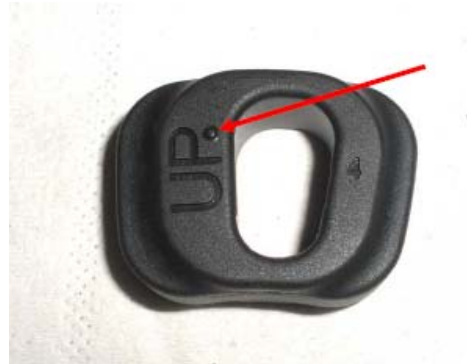
- Remove the clutch basket, it is not necessary to drain the oil for this operation.
- Place on your work bench and remove the 6 screws that retain the stamped plate
- Substitute the cush drive shock absorbers with the new ones that can be identified by the raised point visible in the following photo:

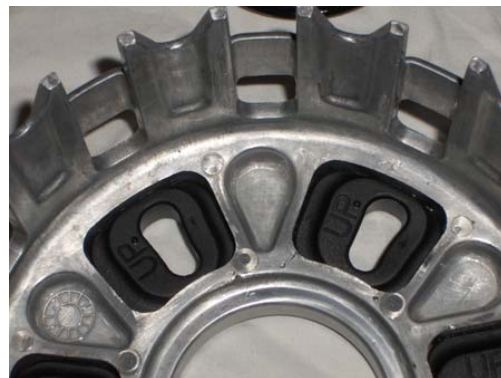
- Position the new cush drive units in the clutch basket with the "UP" as seen in the photo

- Reassemble the clutch basket with the 6 screws (place Loctite on the threads and tighten with 10 Nm of torque).
- Reassemble the motorcycle.
- Please refer to the Service Manual for any information not included in this document.
