TECHNICAL BULLETIN

LTB00463NAS1

Tailgate Window Glass Trim Panel Indentations

Range Rover Sport (LS)

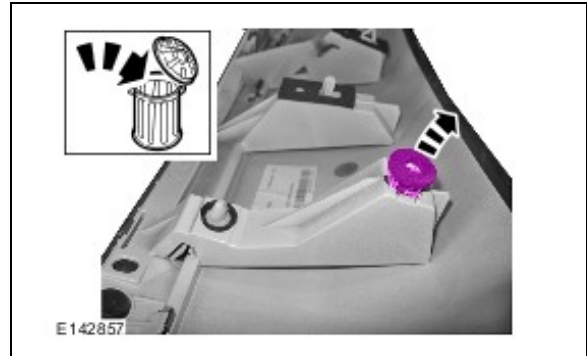
Situation: The rear tailgate window glass trim panel may appear to be uneven or to have indentations.

Cause: This may be caused by the trim panel fixings being over torqued.

1. Refer to Workshop Manual section 501-08 and remove the tailgate window glass trim panel.
2. Use a suitable tool to remove and discard the two fir tree clip inserts.
