# TECHNICAL BULLETIN

UPS0911-4bNAS4

### **Update Prior to Sale: Instrument Cluster Telltales (NHTSA #11V-239)**

XJ (X351)

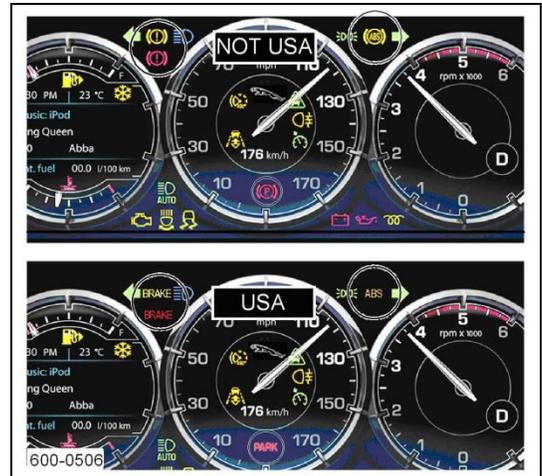
**△ NOTE: The brake warning lamp text will normally only be visible for a few seconds during the cluster bulb check.**

12. After the update has completed, cycle the ignition 'OFF' then 'ON'; verify that the yellow and red brake warning lamps now appear as text rather than icons.
