# TECHNICAL BULLETIN

UPS4512-2bNAS1

### Update Prior to Sale: Engine Bay Harness

XJ (X351)

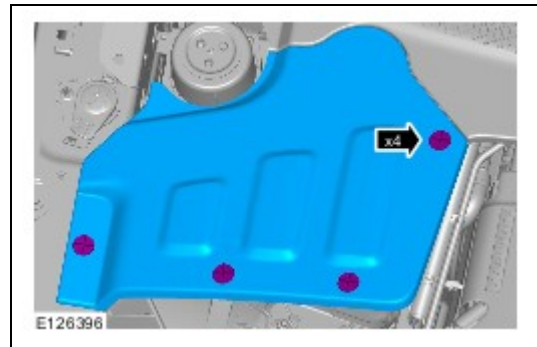
1. Remove the engine compartment fuse box cover.
  - Remove the four (4) clips.

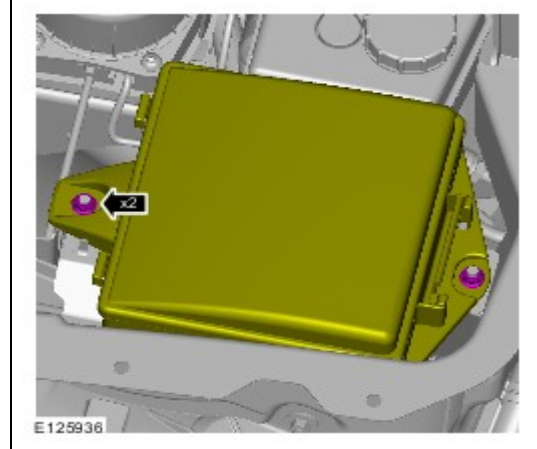
2. Release the fuse box.
  - Remove the two (2) nuts.

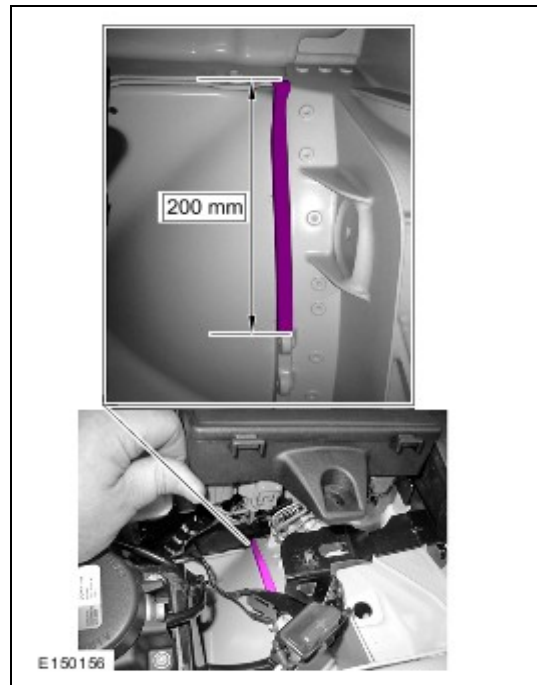
**Situation:** A limited number of 2013 model year XJ vehicles have been manufactured away from process and the engine bay harness may come into contact with the right-hand suspension tower.

**△ NOTE: Make sure protective tape is applied to the area as shown; some vehicles may already have tape fitted but not in the correct area.**

**⚠ CAUTION: Make sure that all sharp edges and corners are covered by the tape.**

Reposition the fuse box and apply a 200mm (8 in.) length of protective tape to the area shown.
