SERVICE BULLETIN

APPLICABILITY: 2012 and 2013MY Impreza and XV Crosstrek™ models with FB Engine

NUMBER: 11-124-12R

SUBJECT: Difficulty Starting, Rough Idle, Cam Position or Misfire DTCs P0301, P0302, P0303 or P0304 DTCs P0340, P0341, P0345 or P0346

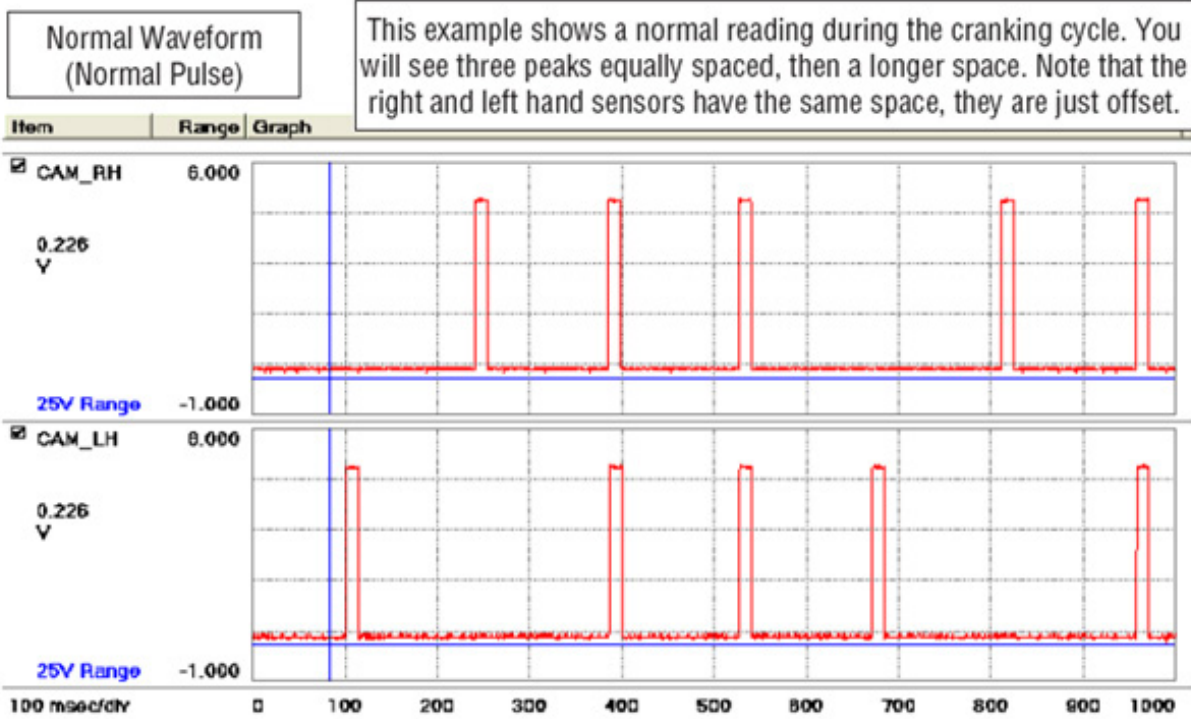
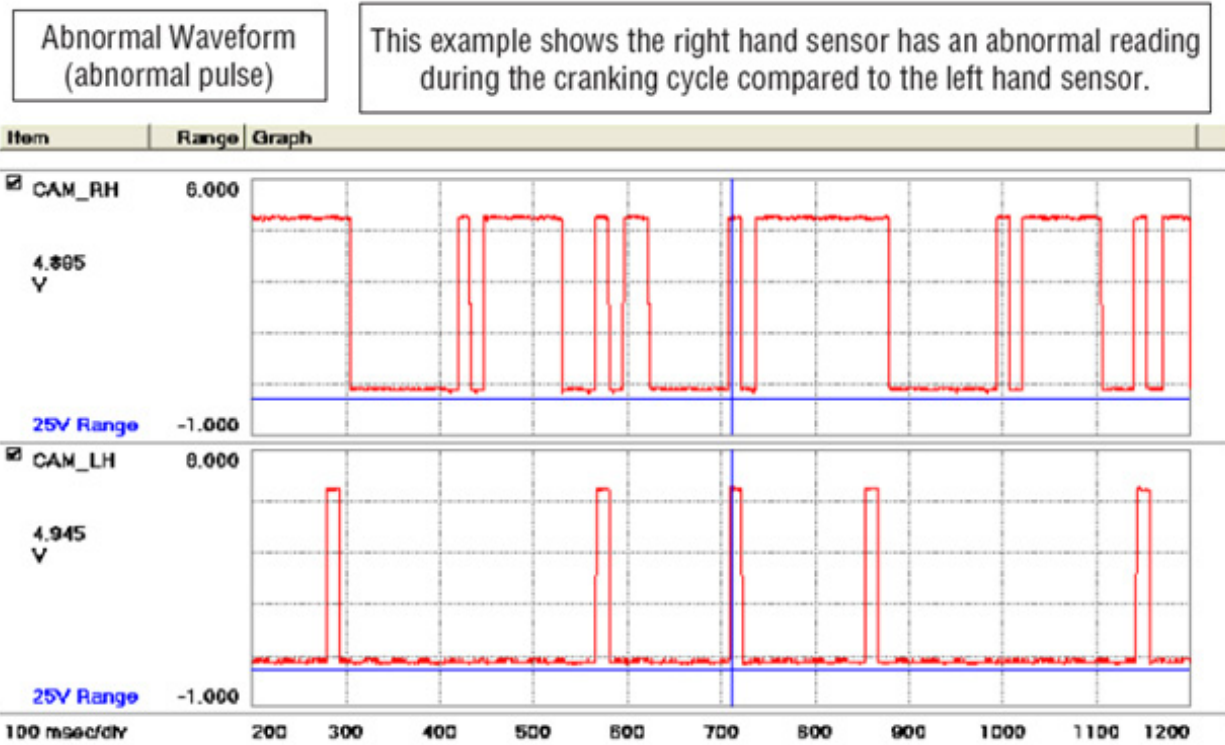
The following illustrations show a normal oscilloscope pattern followed by an abnormal pattern.

If an abnormal pattern is verified similar to those shown in the illustration above, measure the clearance between the end of the camshaft position sensor and the sensor plate using the following procedure. If the oscilloscope pattern is normal, refer to the applicable Service Manual for additional troubleshooting and diagnostic procedures.

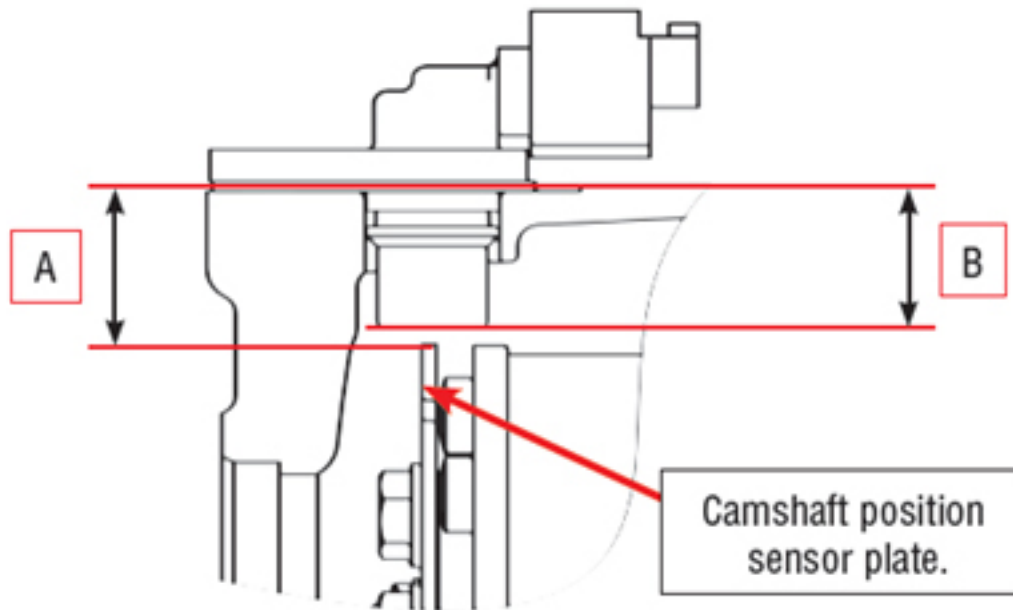
MEASUREMENTS:

A= Top surface of the timing chain cover to camshaft sensor plate

B= Camshaft Position Sensor mating surface to the bottom of the sensor

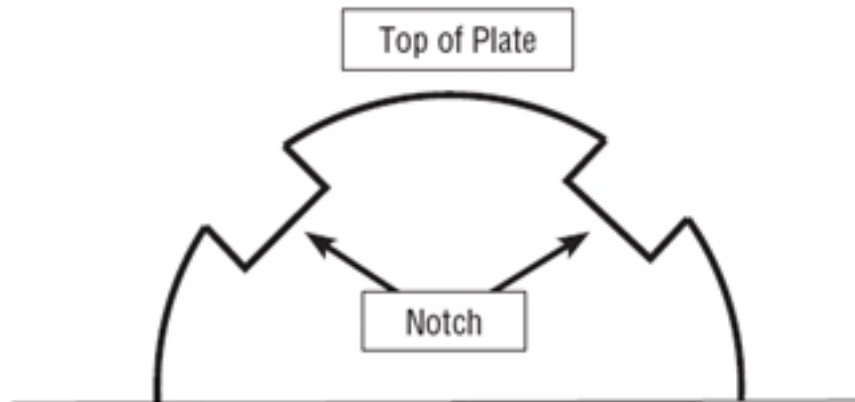
NOTE: When measuring “A”, make sure you are measuring to the outside diameter or “top” of the sensor plate and not to the bottom of a notch as shown below. Be sure to record all measurements.

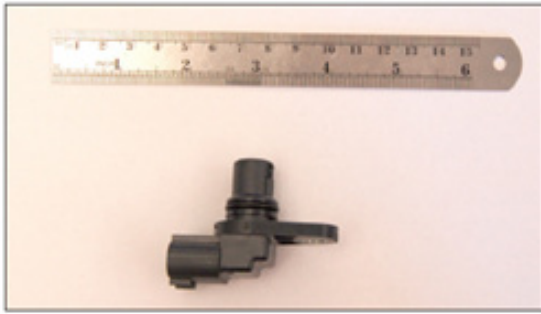
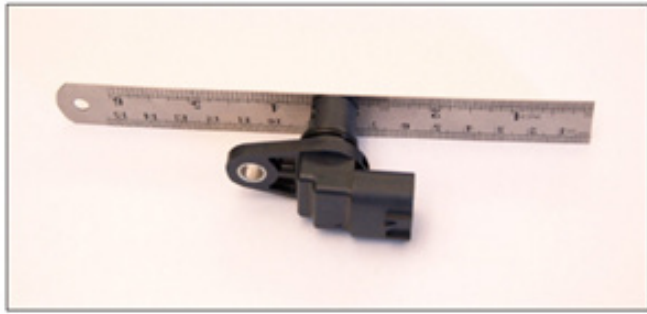
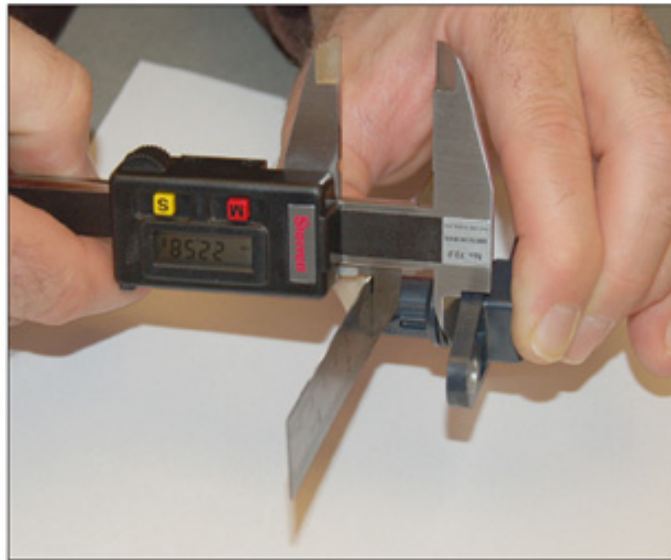
When taking measurement “B”, use a flat steel ruler or equivalent.

Measure the camshaft position sensor mating surface (the area that sits flush on the timing chain cover) to the bottom of the sensor and record measurement.
