SERVICE BULLETIN

APPLICABILITY: 2008-2010MY 5-Door Impreza **NUMBER:** 07-71-12
SUBJECT: Revised Packing Material for the License Plate Lamp **DATE:** 12/03/12

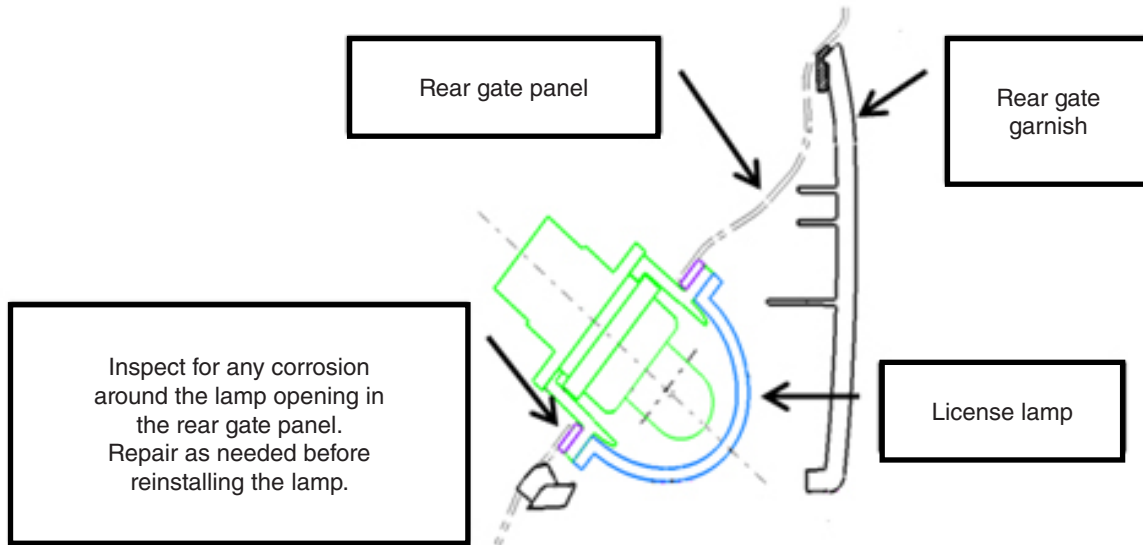
The packing (gasket) material for the license plate lamp has been revised to improve the sealing performance to the rear gate panel. The new material is thicker to provide a better seal and help prevent corrosion which may develop as a result of contact between edges of the lamp assembly and the paint finish.

Cross-Sectional View of License Lamp and Rear Gate

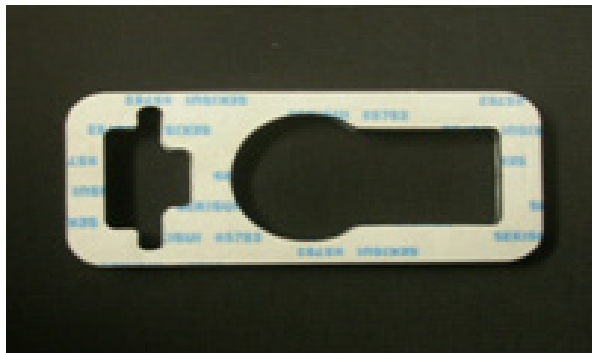
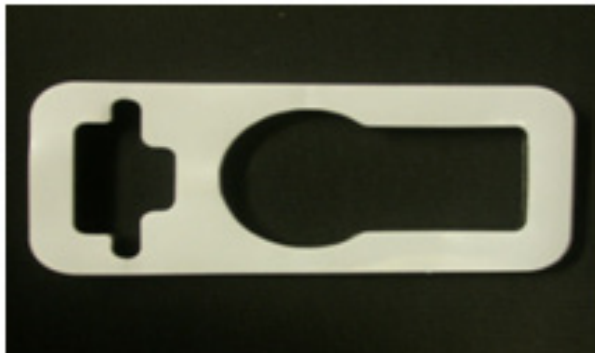
The photos above show the new packing material. The side with lettering is the adhesive side (left).

- Once the license lamp is completely clean and dry, peel the paper from the adhesive side and carefully attach it to the back of the lamp making sure none of the new packing extends over the edges. Work out any trapped air bubbles to the closest edge.
- Confirm any paint repairs to the lamp opening in the rear gate are completely dry before reinstalling the license lamp.
