# Technical Bulletin

**58 12 05** November 2, 2012 **2021668** Supersedes T. B. V580902 dated October 5, 2009 to update water test labor operation.

### Rear Doors, Outer Seal, Water Retention at Sill Plate

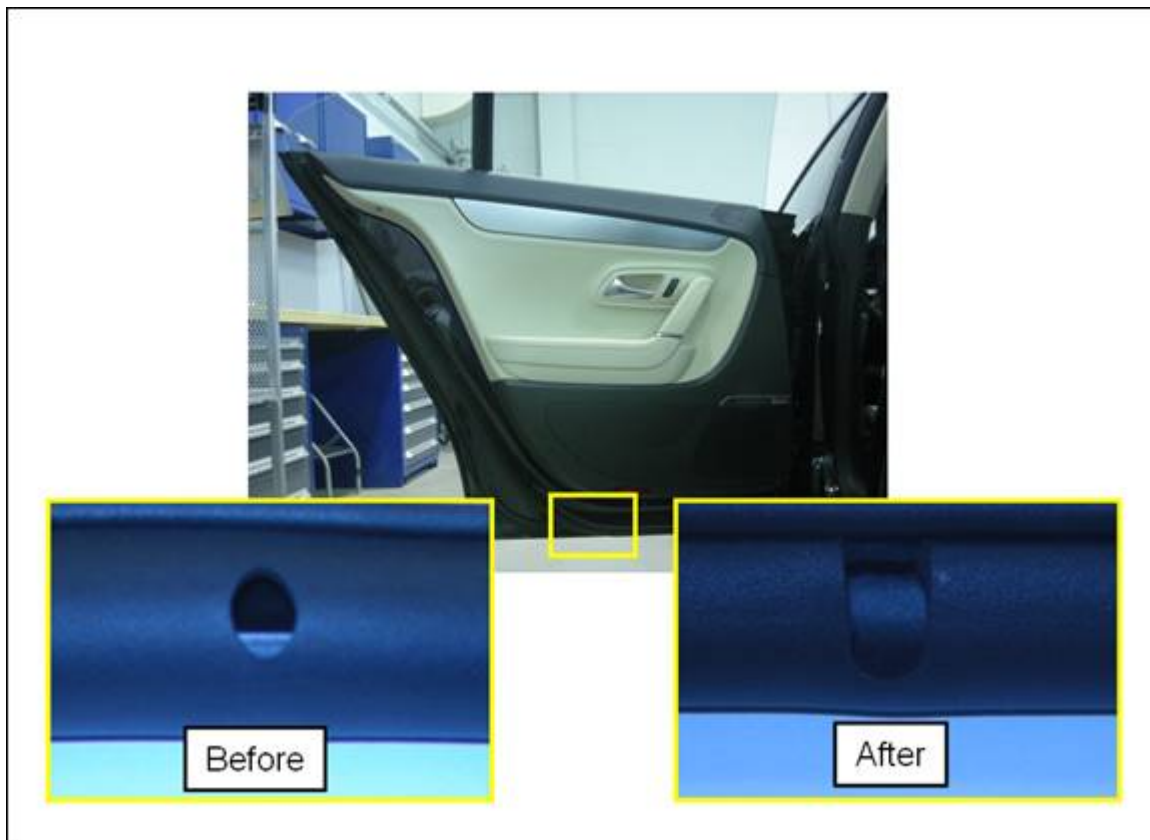
1. Locate rear door outer seal inner drain hole, see photo below.
