# UPDATE Technical Bulletin

## UPDATE – 90H2 Instrument Cluster (NVLW) – U.S. ONLY

UPDATE 90H2 Instrument Cluster (NVLW)

Model(s)	Year	Engine Code	Trans. Code	From	To
Jetta Sedan	2012 - 2013	All	All	3VW__AJ_CM033700	3VW__AJ_DM386273

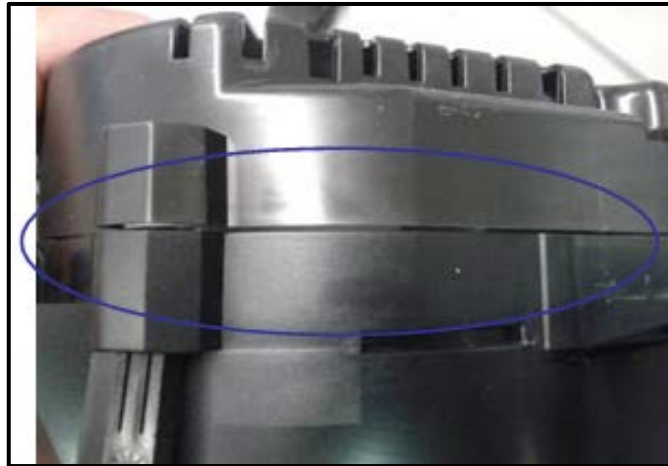
Picture 1

This update has been proactively released to prevent customer concerns related to clock and trip meter adjustment using the instrument cluster buttons. Because of a fitment concern between the instrument cluster halves the buttons mounted on the instrument cluster may not function properly.

Since the lower housing does not fit properly with the upper housing, the buttons do not make contact when time and/or trip meter is being set. See Picture 1.

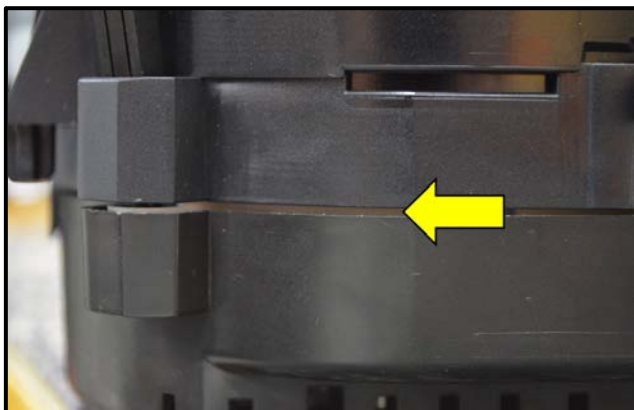
- With the instrument cluster removed from the vehicle inspect the seam between the two instrument cluster halves <arrow>.

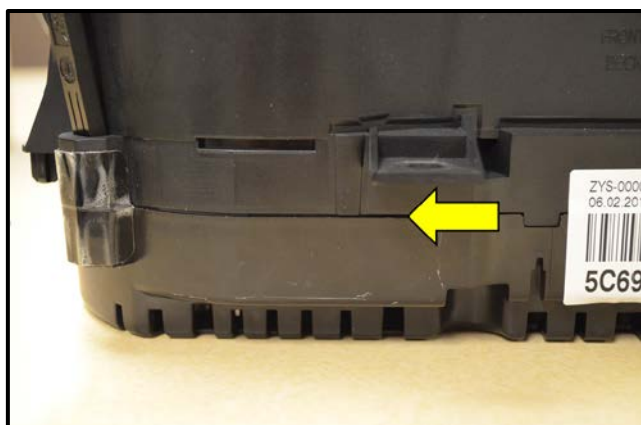
⇐ Inspect instrument cluster thoroughly to ensure both halves are fully seated and fastened together <arrow>.

With the repair complete, the seam gap will be approximately 1mm.
